NUMBER 253
ISSN 0 727 8101

LIGHT RAILWAYS

Australia's Magazine of Industrial & Narrow Gauge Railways

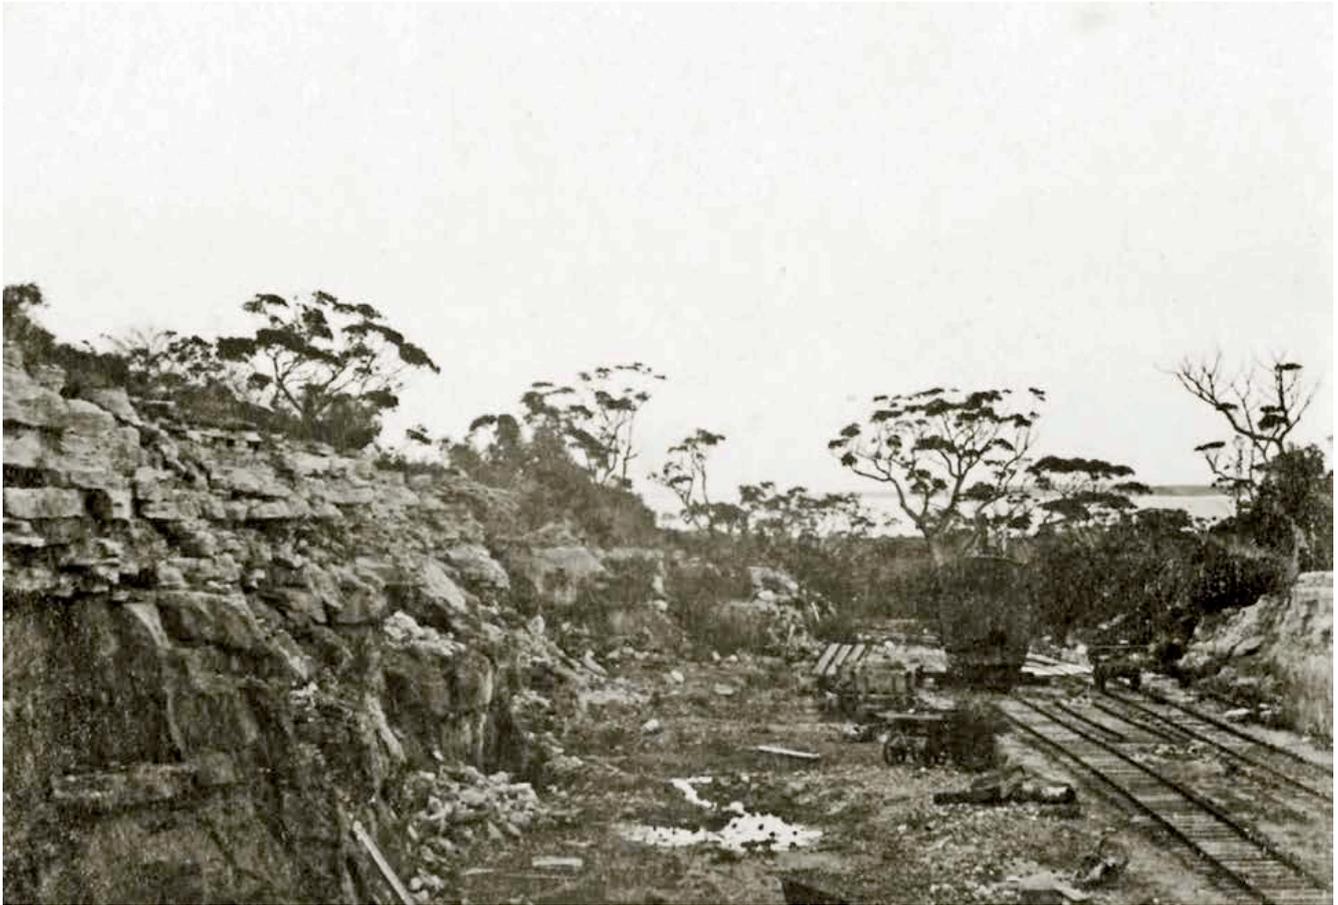
Above: The second quarry, with rail lines, a trolley, and possibly locomotive 530. Date unknown. The photograph has been enhanced as much as possible.

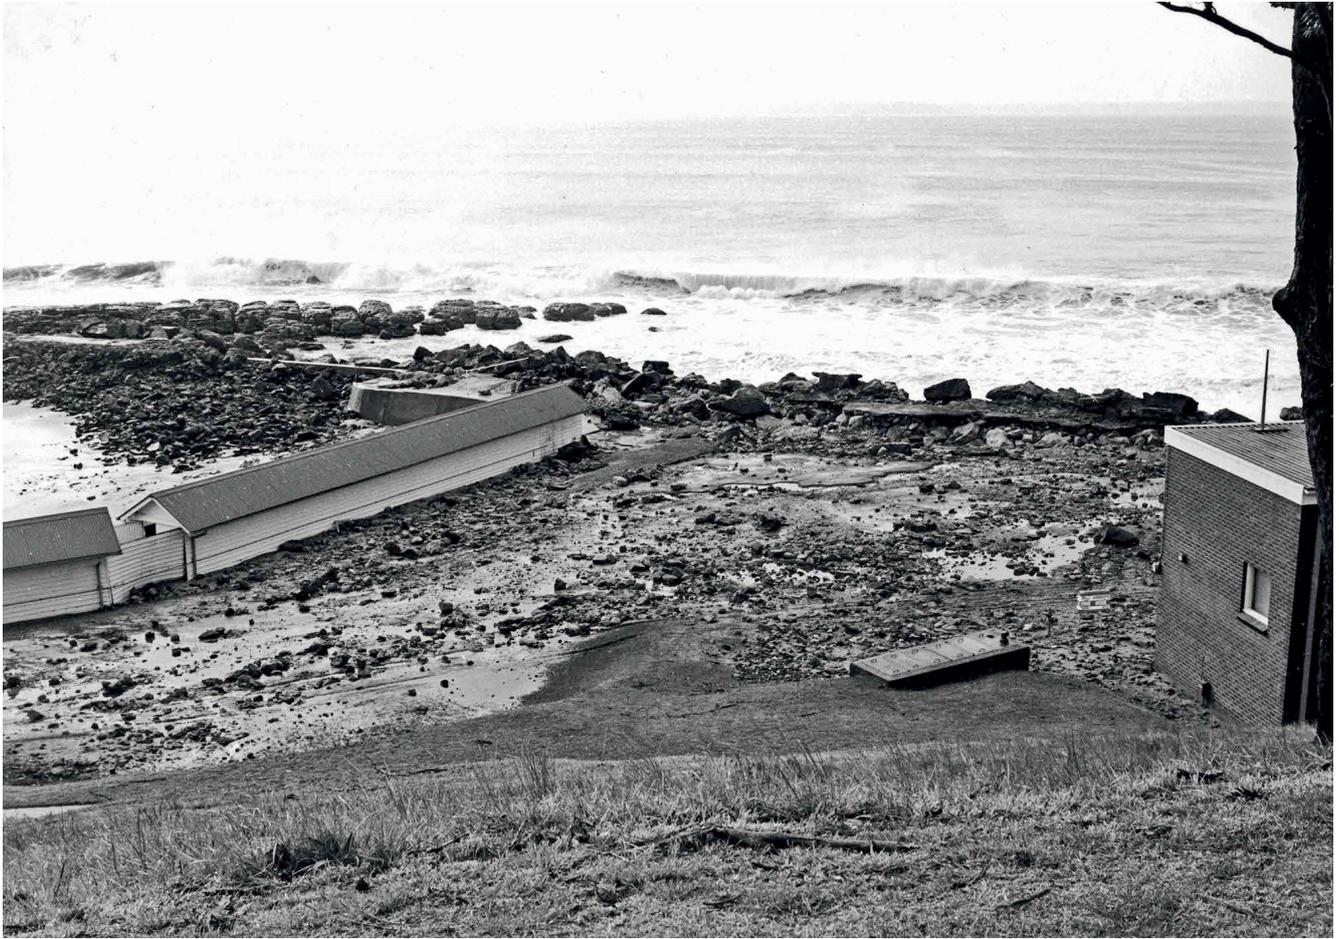
Above: A view of the storm damage to the College Breakwater, June 1975.

The College was buffeted by one of the most severe storms ever experienced in this area on Saturday 21 June. A heavy swell accompanied the high winds producing a pounding surf estimated at 20 to 25 feet high. This, exacerbated by spring tides with high water at 1835, caused extensive damage at the waterfront including the sinking of the College yacht, CALLALA.

Following temporary repairs, the major reconstruction of the Breakwater was a costly undertaking, over \$300,000. The Commanding Officer's report of 30 April 1976, provided a salutary warning (as well as suggesting that Blomfield had been right after all).

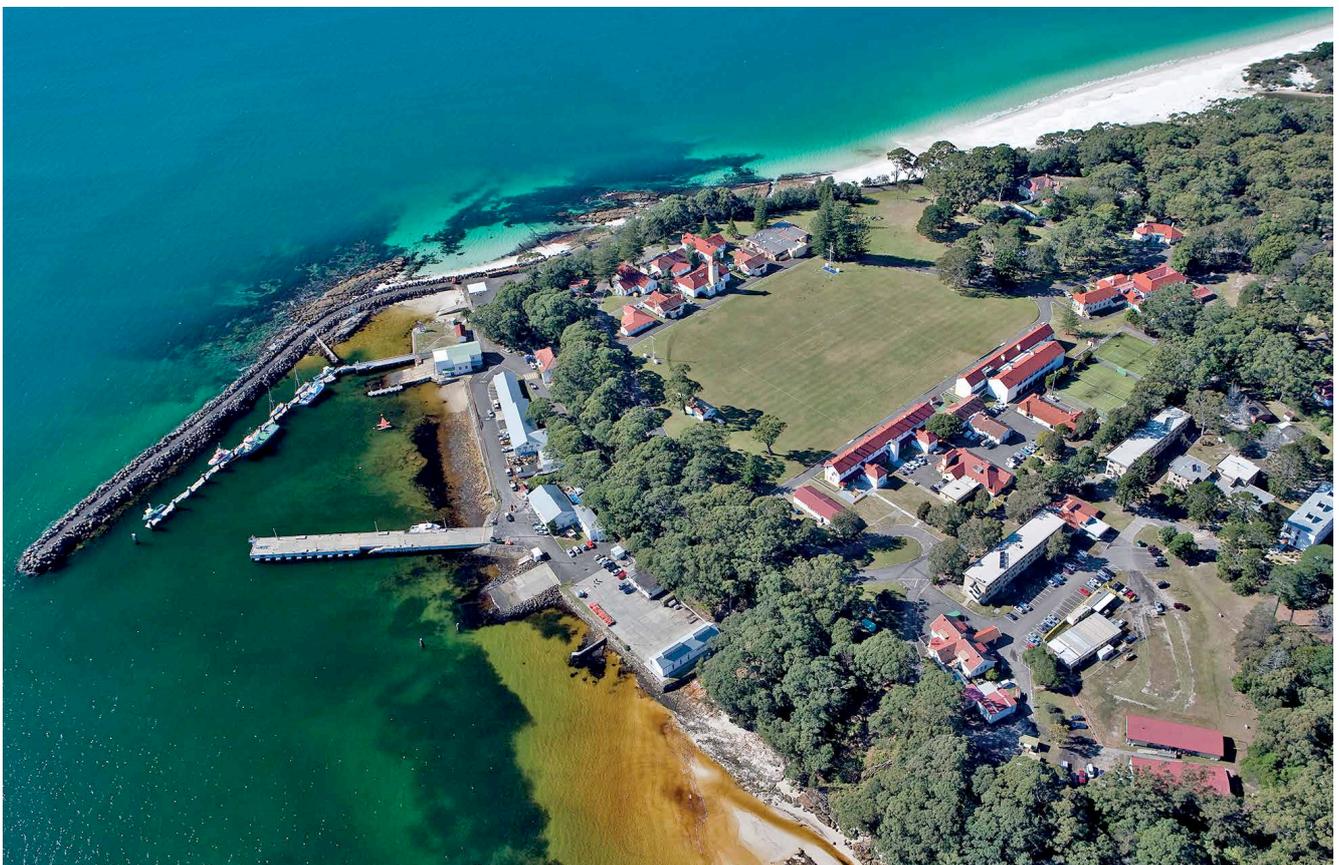
Below: The Royal Australian Naval College Breakwater, with some of the College buildings, 2010.

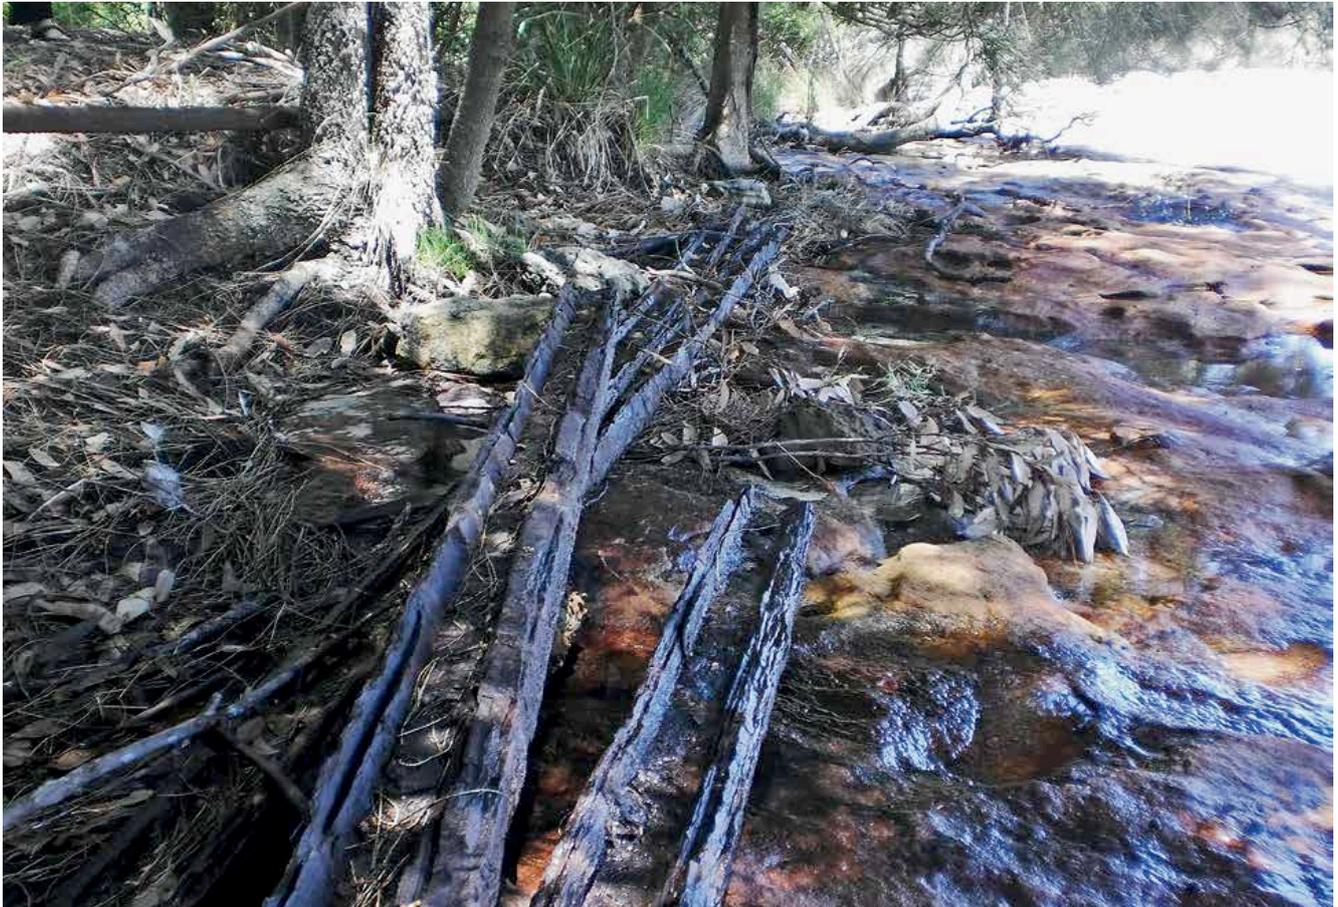
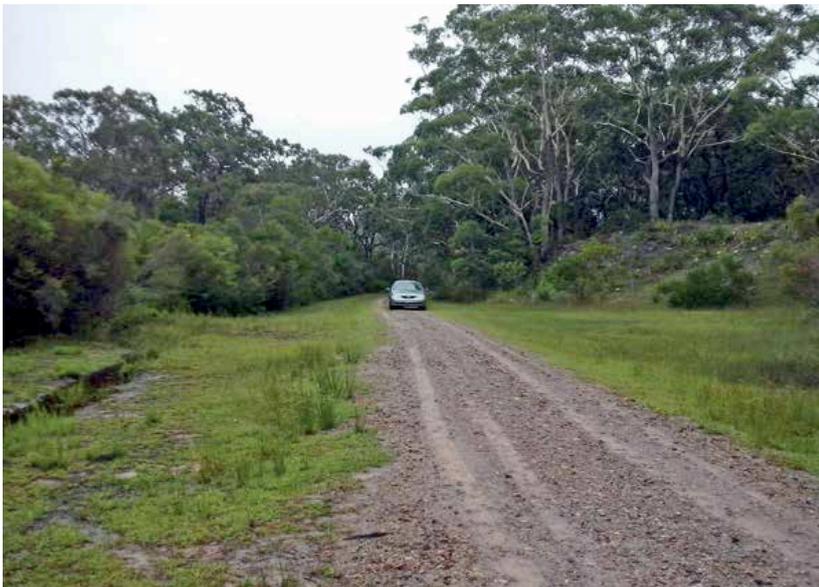
***Above:** Remains of tramway tracks before removal to the Museum, November, 2012.
Source: Ailsa Chittick, Collections Curator, HMAS Creswell Historical Collection*
***Left:** Location of first quarry and route of tramway, April, 2014.
Source: Lieutenant Commander David Jones, RANR, HMAS Creswell Historical Collection*

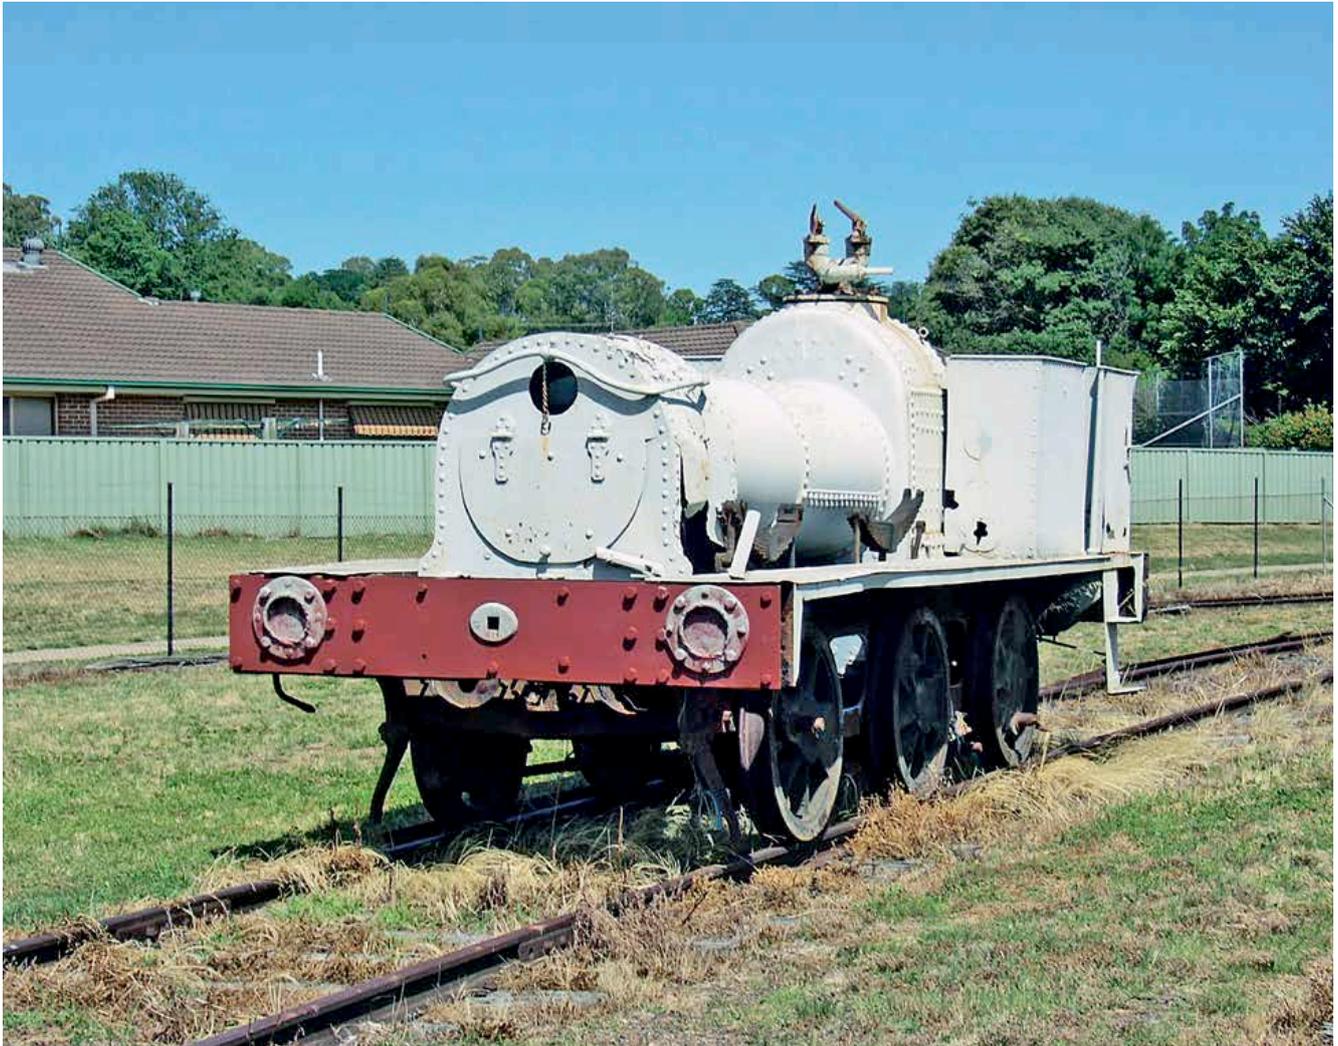
The remains of locomotive 530 awaiting further restoration at the Yass Town Railway Museum, December 9, 2012. Important parts missing are the stovepipe chimney, the circular saddle tank, and the rounded cabin and roof. Source: Peter Crabb

between the author’s visits in December 2012, and November 2015. It has only gathered more rust. Unfortunately, the task is beyond the financial and other resources of the dedicated but very small group of volunteers.

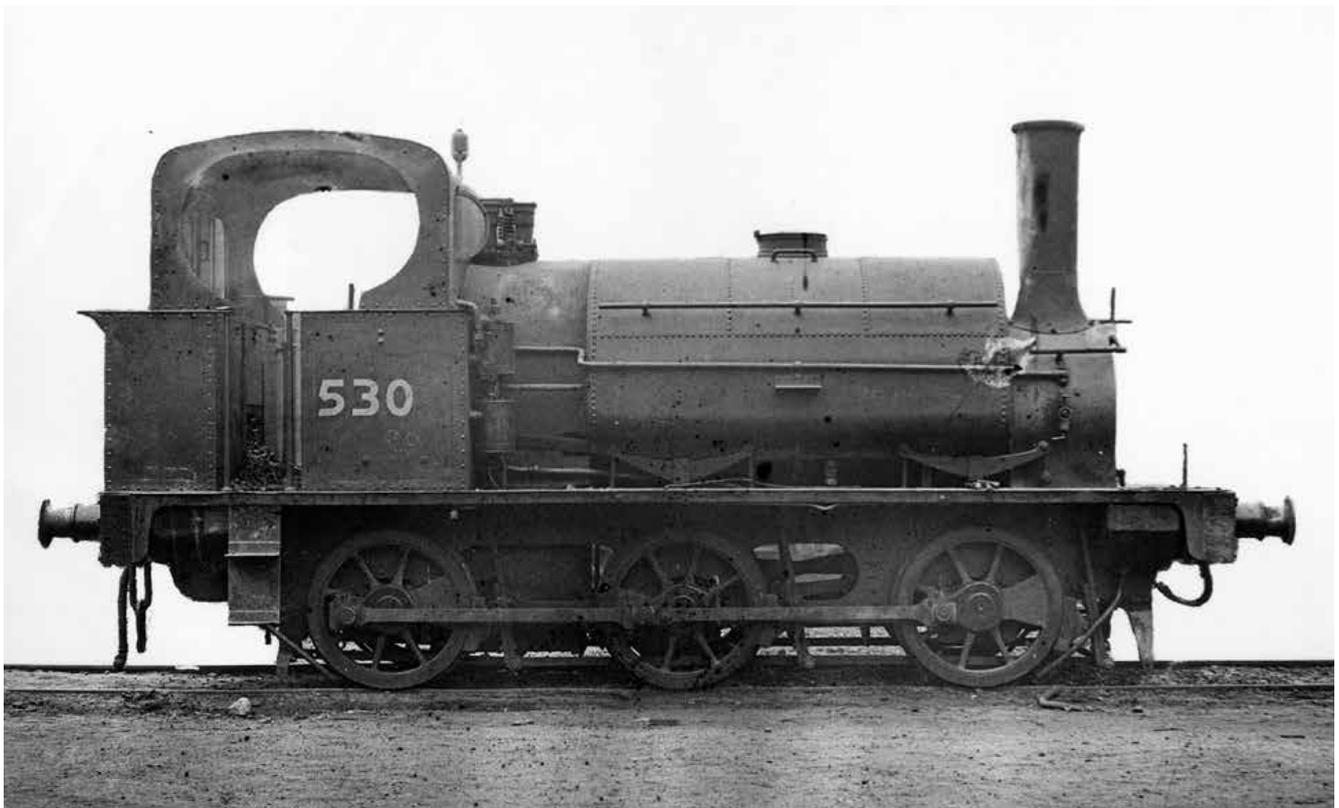
The three members of the 127 Class (Nos 127-129) were built by Vulcan Foundry, Newton-le-Willows, England (B/Nos 833-835 of 1879) and delivered to the NSW Government Railways for use on the Richmond branch, west of Sydney, where the traffic had outgrown the capabilities of the three small Manning Wardle 0-6-OST 29 Class locomotives. Later, they saw use on the Sans Souci, Camden and Yass tramways. In 1891 they became the P(127) Class, and in 1897 they were all renumbered, with P128 becoming 530. This image is thought to date from around that period. In 1915, 530 was sold to the Commonwealth Government for use at Jervis Bay.

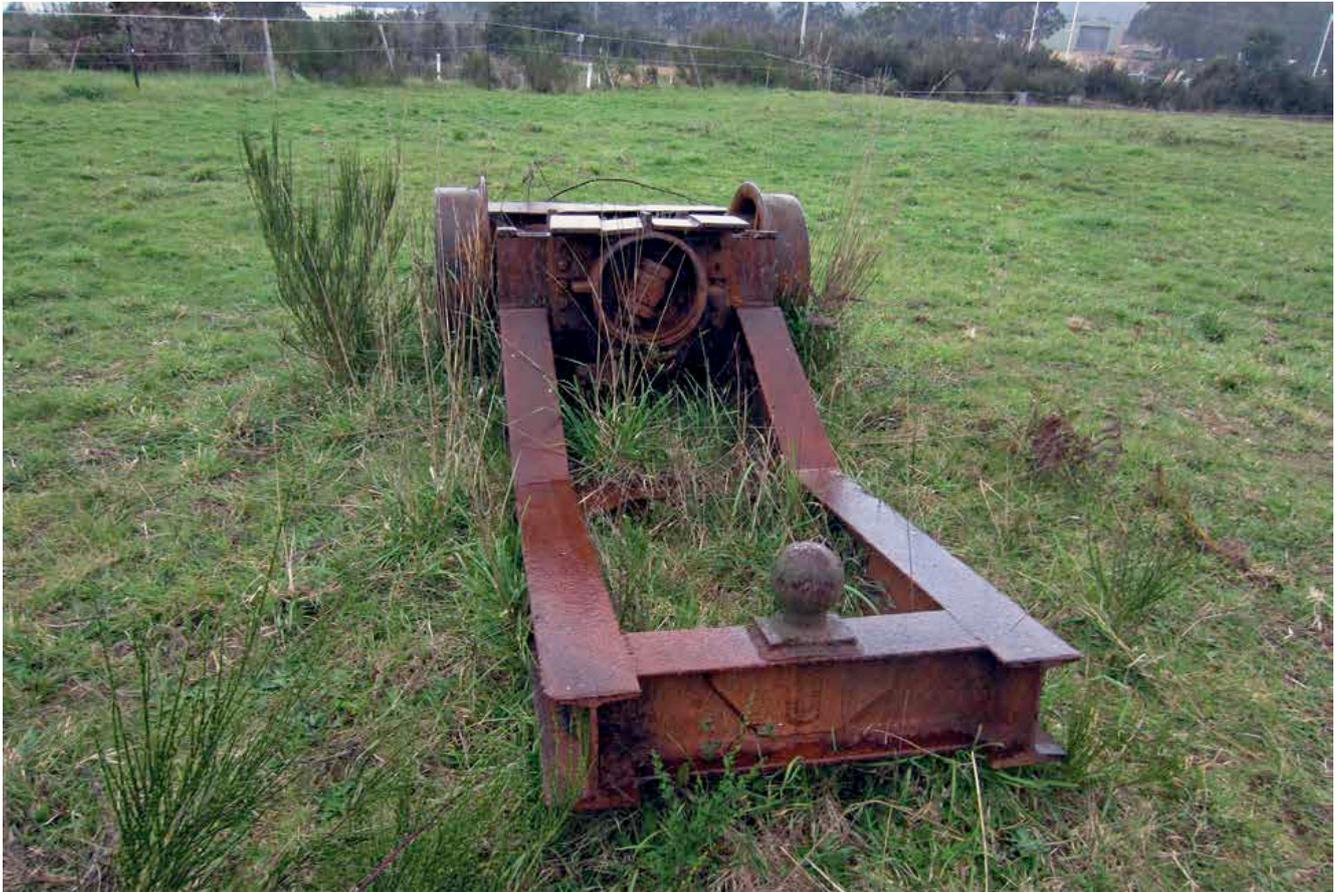
A front-end view of the 'mystery frame' or assembly, as it lay upside in a paddock about 250 metres from the former Raminea Mill site. It had been moved there during a clean-up of the mill precinct; it is understood that many other mill artefacts were disposed of elsewhere during the clean-up. Note the cranked stringers, and the large (120 mm dia) tow-ball which, in the normal (inverted) orientation, apparently sat into a housing in the ex-Byers bogie, thus providing The Caterpillar's with leading articulated support. Photo: JS Clennett Sept 2016

The photo shows that first four wheelsets (and, by deduction, the fifth, being the one obscured by the man standing beside the assembly, but shown in other photographs) are clearly from the Byers, evidenced by their geometry and linkage holes. While this implies that the old eight-wheeled Byers perhaps had at least ten wheels, it should be noted that extra wheelsets had apparently been supplied at some stage.

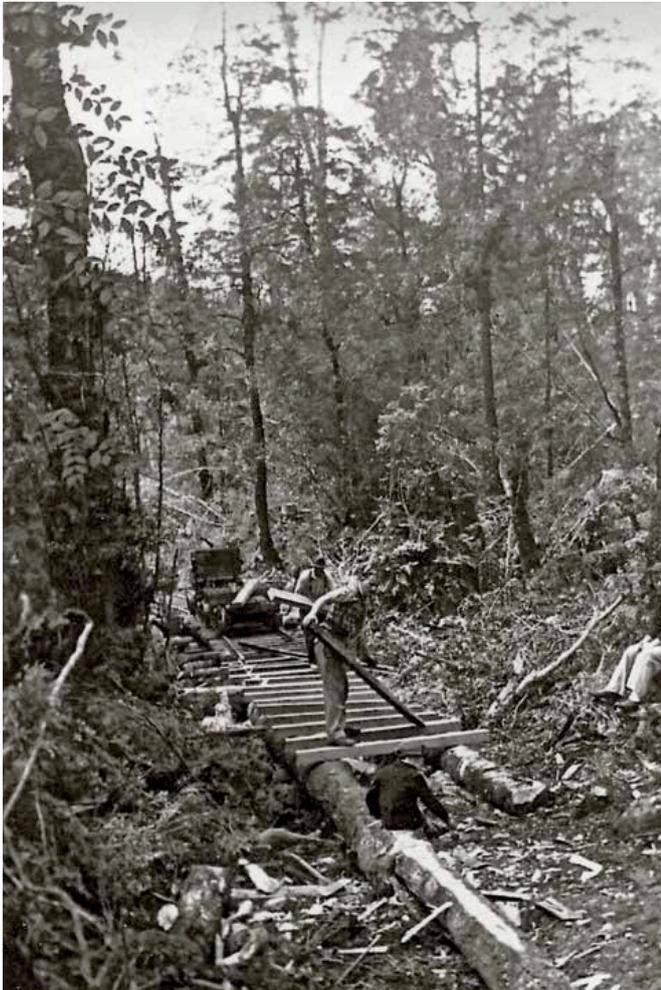
Left: The last parts of the Esperance River tram were built in 1949. Here, the gang is building a waterway crossing by laying down logs as stringers, and topping them with sleepers. John Casey, who is the man standing on the nearest sleeper, told that longitudinal continuity of the stringers was achieved by scarf-jointing one to the next. Note the lightness of the rails: some rail from Raminea that was measured by the writer in 2003 was of 30 lb/yd (15 kg/metre), and while some heavier rail may have been used at times, it is unlikely that much if any exceeded 40lb/yd (20 kg/metre). The identities of the other two men is unknown, but the person almost out of picture on the right was one of the photographer's children. This is one of only three photographs of The Caterpillar known to the writer - and one of those shows it on its side! At least it sits upright here on completed track in the background. It was during these construction works, on a steeper part of the track, that the second capsized of the locomotive occurred, curing John Casey of wanting to drive it anymore. Photo Cyril McCoy, 1949, courtesy John Casey

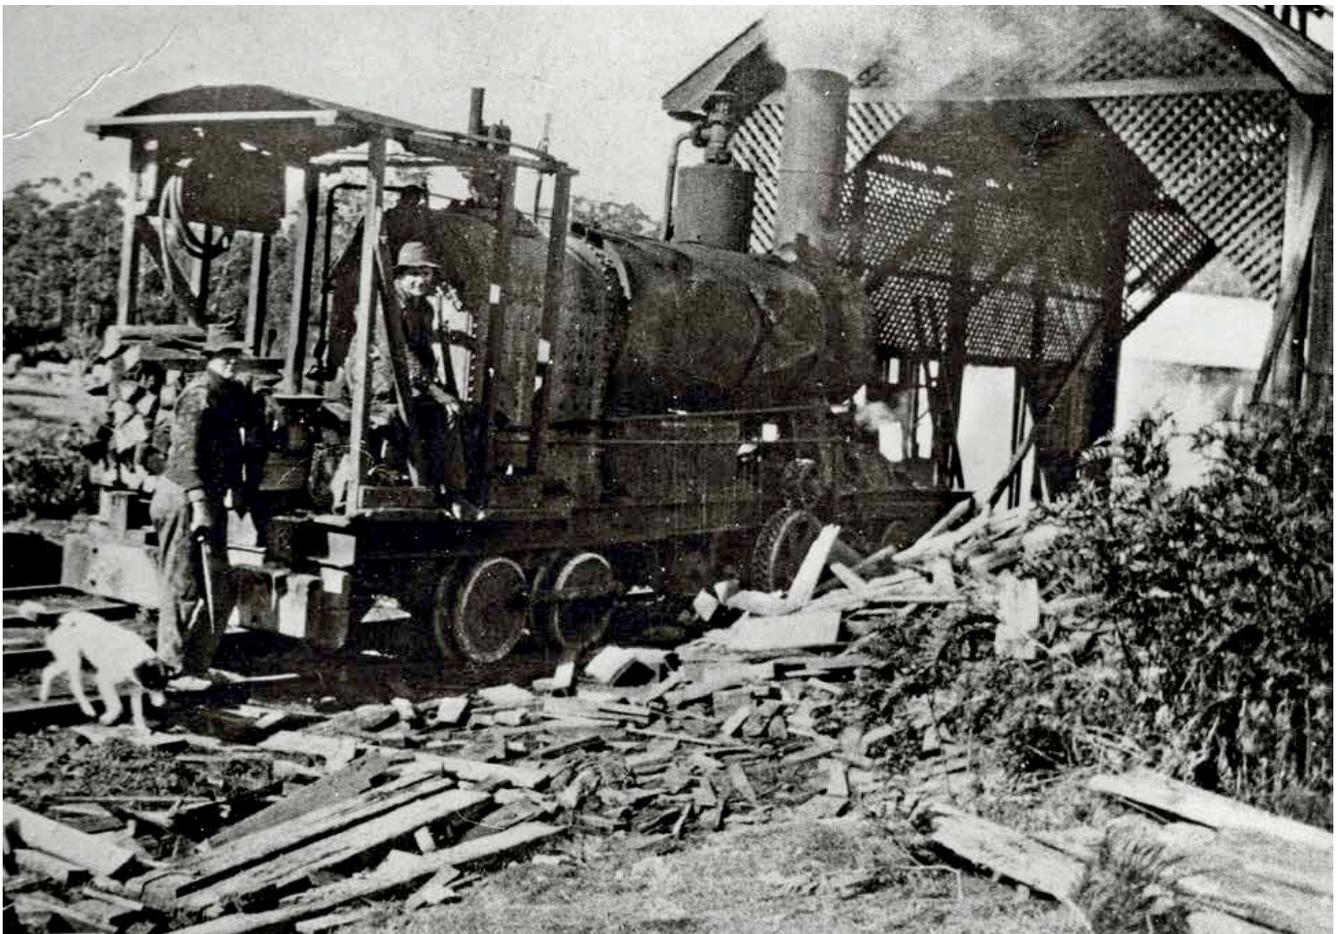
Below: Like many of the locomotives that appeared in the Tasmanian forests over the years, The Byers was a strange beast, perhaps springing from the concepts of North American lumber locomotives such as the Shay and the Climax, with their two powered bogies, driven via special gearing, giving good articulation, and powerful but slow traction on crudely built, steep, and often curvy track. The Byers also had two four wheeled bogies but this photo only shows the rear bogie, the other is obscured by the scrap timber, but note the wheel linkage rod; these were replaced with chain linkages in the re-incarnation as the Caterpillar's powered trailing bogie, evidence the holes in the otherwise spoke-less wheels in other photographs. This photo dates from about 1930, and shows the locomotive outside its shed with Paddy Casey as driver, and Harry Stennings standing; (the dog was 'Kluga'!). It was taken about 18 years after the one on page 90 of Engaging the Giants, which was published in the Weekly Courier when the locomotive was new, and which showed it fitted with a crude spark arrester.

arrived to take over.⁴ This unit, known as *The Byers*, had two articulated four-wheeled powered bogies, and continued as the workhorse on the system until 1939. On withdrawal, its steam engine was taken off elsewhere, but the frame and bogies were put aside at the mill.

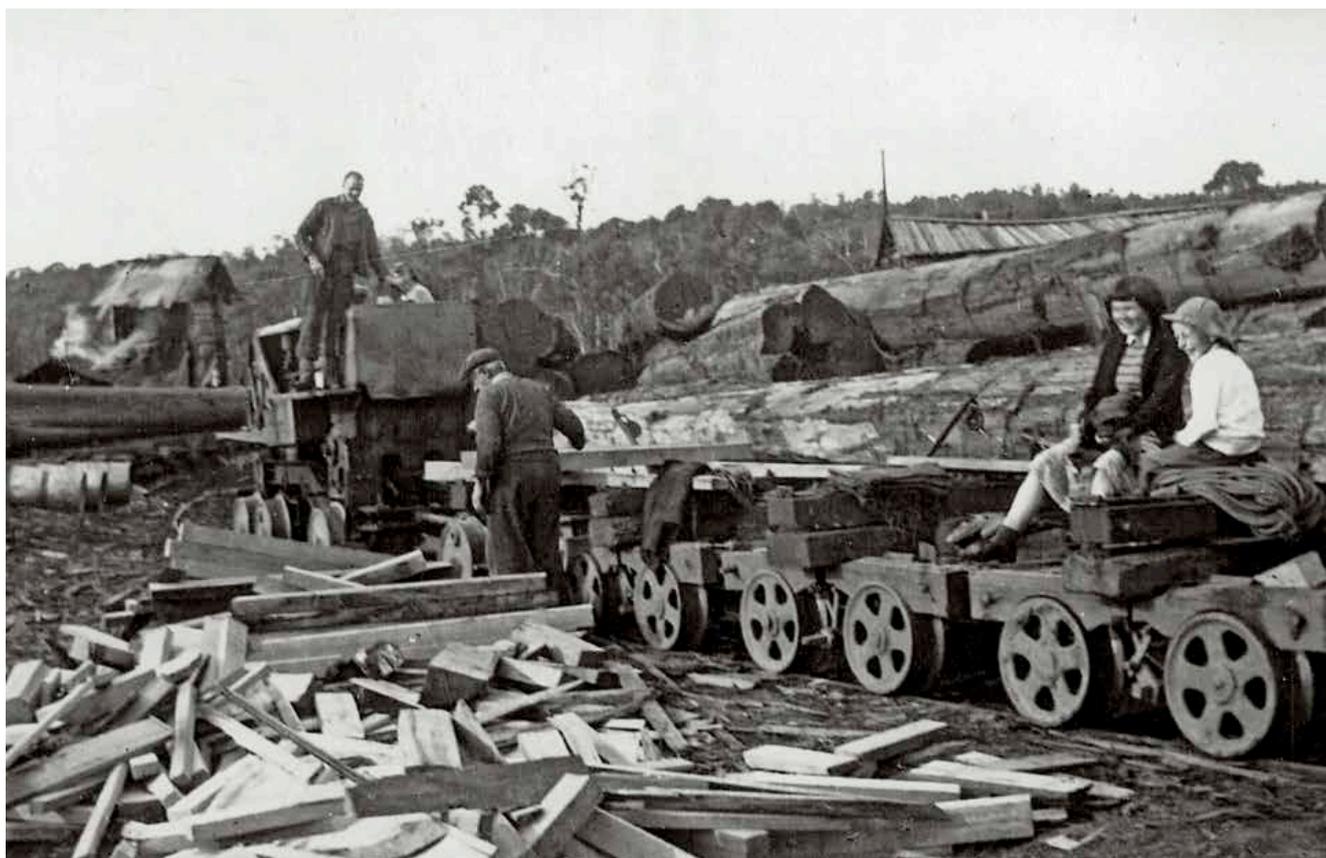
This photograph of the Caterpillar and its rake of log bogies, taken in the Raminea Mill yard in the late 1940s, was provided by John Casey, and annotated with the names of four of the five people shown: a young Jim Casey is standing on the 'footplate' of the locomotive, with an elderly Ben Careless standing on the ground. The children sitting on the log bogie are Helen and Tom McCoy, but the identity of the girl sitting in the Caterpillar by Jim Casey's left hand is not known. The photographer was Cyril McCoy, the children's father and the local schoolteacher. The crank in the left-hand side stringer of the chassis, although somewhat indistinct, can be seen directly under Jim Casey's feet, while the wheels of the leading bogie, and of the chassis itself are quite clear. The trailing powered bogie is beside Ben Careless, with its rear wheel being obscured by his legs. Note the wooden brake blocks on the log-bogies' wheels and the square-sectioned shafts protruding from between those wheels, apparently mechanism to apply these brakes. It is probable the frames of these bogies, hidden by the brake blocks, were of steel, as shown in other photos. It is quite obvious why the Caterpillar was thought to be top heavy.

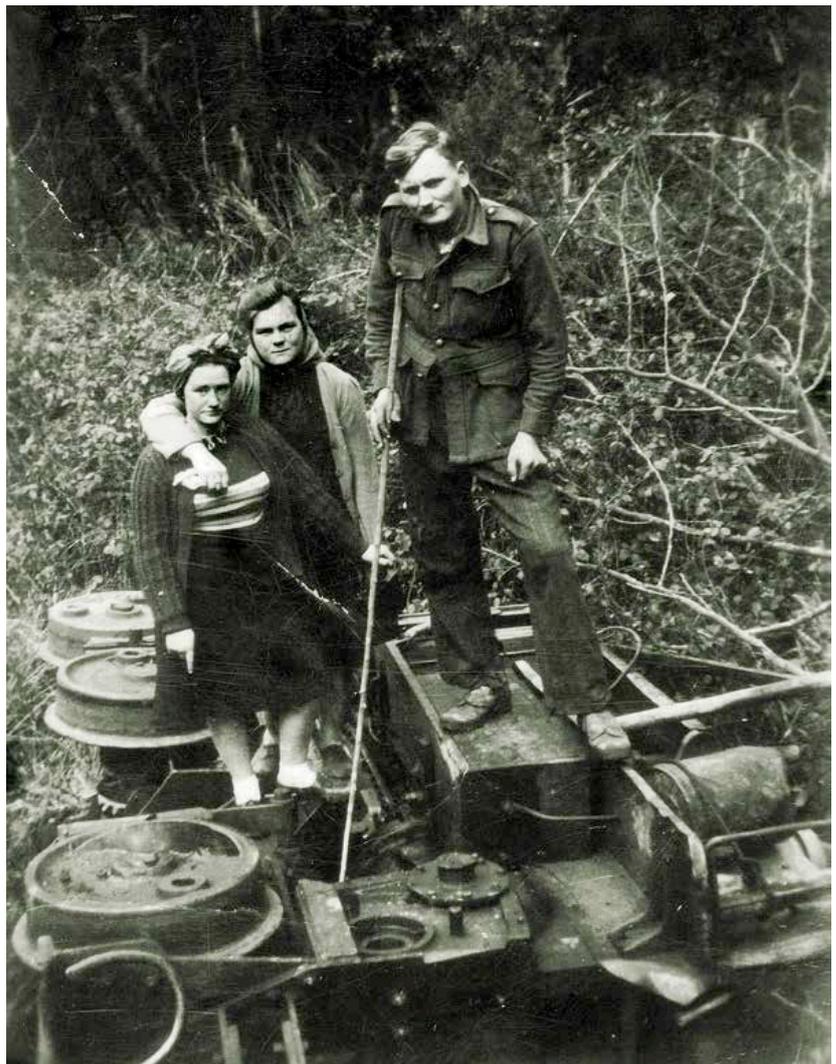
Right: The Caterpillar capsized at least twice. This photo was taken after one of those accidents, with the unit lying on its right side. John Casey is standing on the superstructure with the stick, while the two girls are his sister Pat Casey (L), and her friend Emma Dale. The girls are standing on the cranked left-side frame stringer. The leading bogie wheels, and that of the mystery assembly are evident.

And so, a week or so later, down to Raminea and Dover to find the assembly, and to talk with John Casey, who, as a young man in the 1940s, had driven *The Caterpillar* on the tramway. As noted below, he had also managed to capsize it, twice! Apparently, it was notoriously unstable – from photographs it certainly appears to be quite top-heavy.

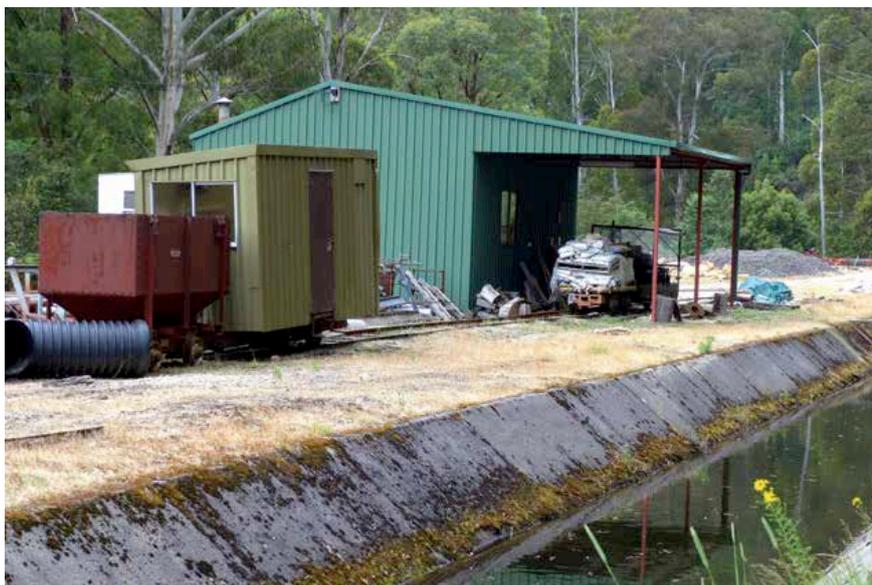
General view of the Bogong Creek raceline tramway depot on 6 December with the Motor Rail 'Simplex' 4wDM (7366 of 1939) inside. The 'garden shed on wheels' is the mobile crew room. Photo Phil Rickard

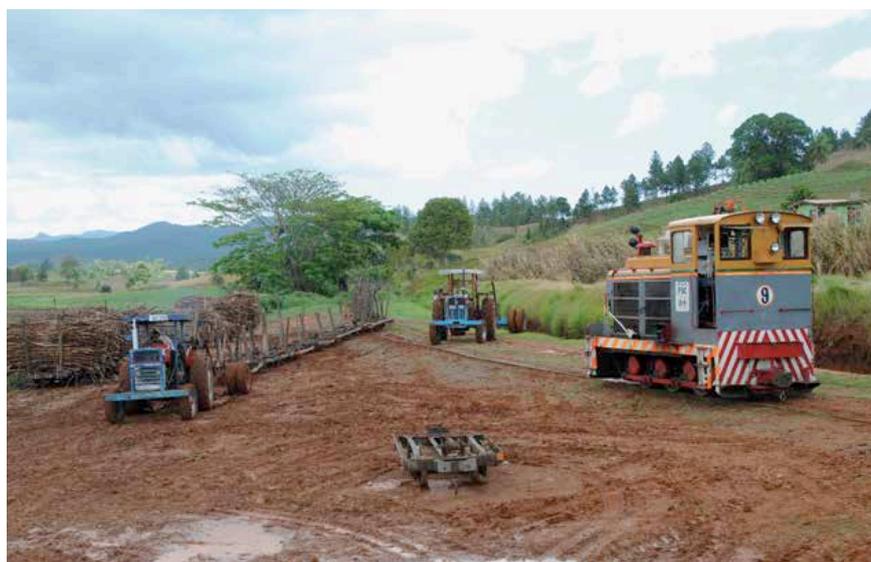
Owing to inadequate siding infrastructure amongst other things, overlanding of empty cane trucks has become common practice in Fiji and in this scene on 20 October, Labasa Mill Clyde 0-6-ODH 9 (62-270 of 1962) stands by while tractors yank their shares of trucks out of its rake of empties at Vuliaki. Photo: John Browning

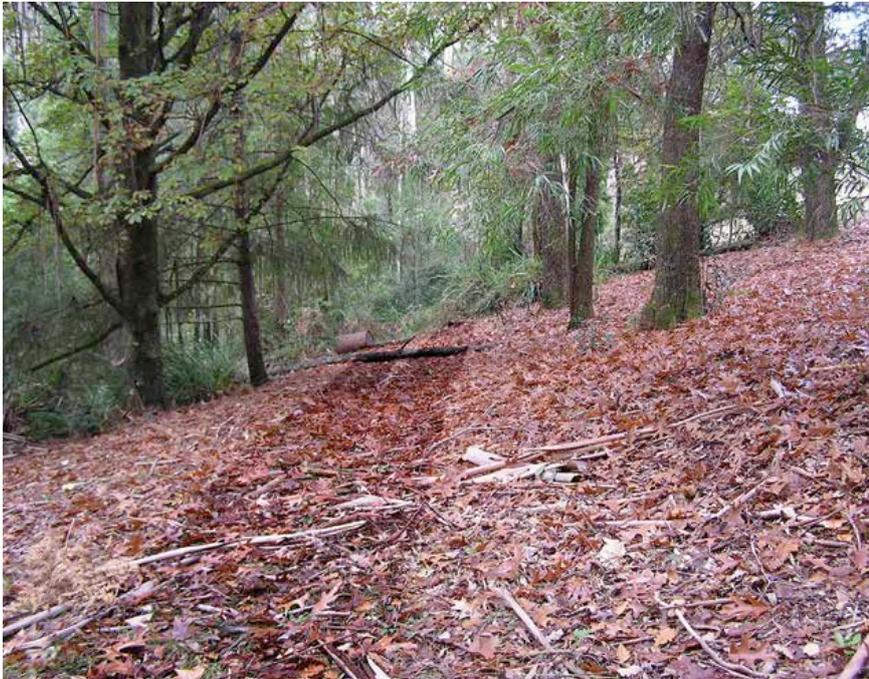
In the North-East corner of the training ground can be found the alignment of Russell's tramway. Highly eroded over the years it can be difficult to see in bright sunlight. This view shows the junction point of the tramways to the Tomahawk Creek mill to the left (north) and the Swallowfield mill to the right (east). It also shows the southern abutment of the high trestle bridge that once crossed Clark Creek at this point. Ground indentation suggests the possible location of a base log for a trestle. The formation has been digitally highlight in this image.

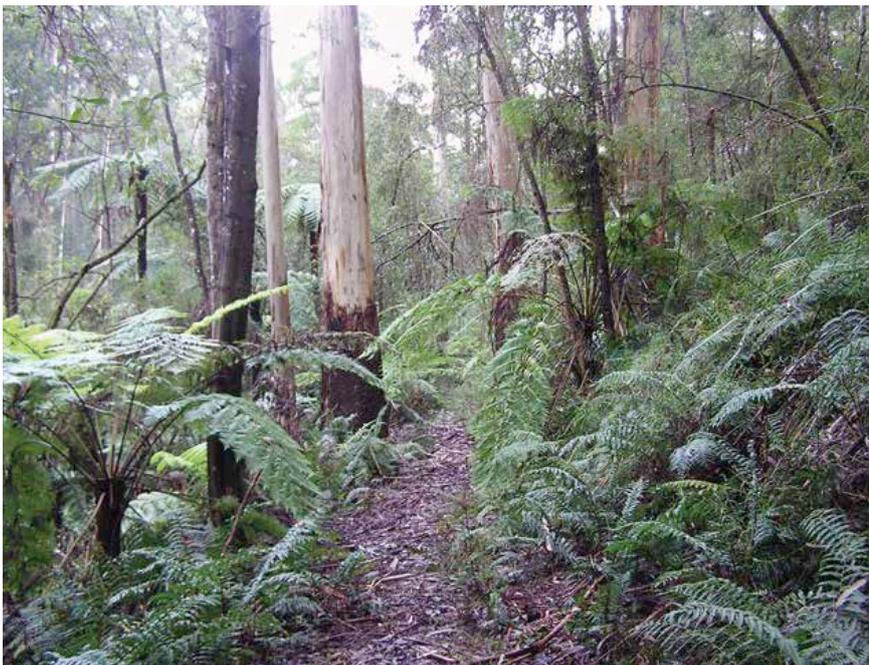
The alignment of the tramway to the Tomahawk Creek mill can easily be followed along the west side of the gully running north from Gilwell Park. Unfortunately, the ease of passage is largely due to it having been bulldozed at some point. Nevertheless, it remains a pleasant walk although the 1 in 14 grade can mean hard going in hot weather.
