LIGHT RAILWAYS

Australia's Magazine of Industrial & Narrow Gauge Railways

No 264 December 2018

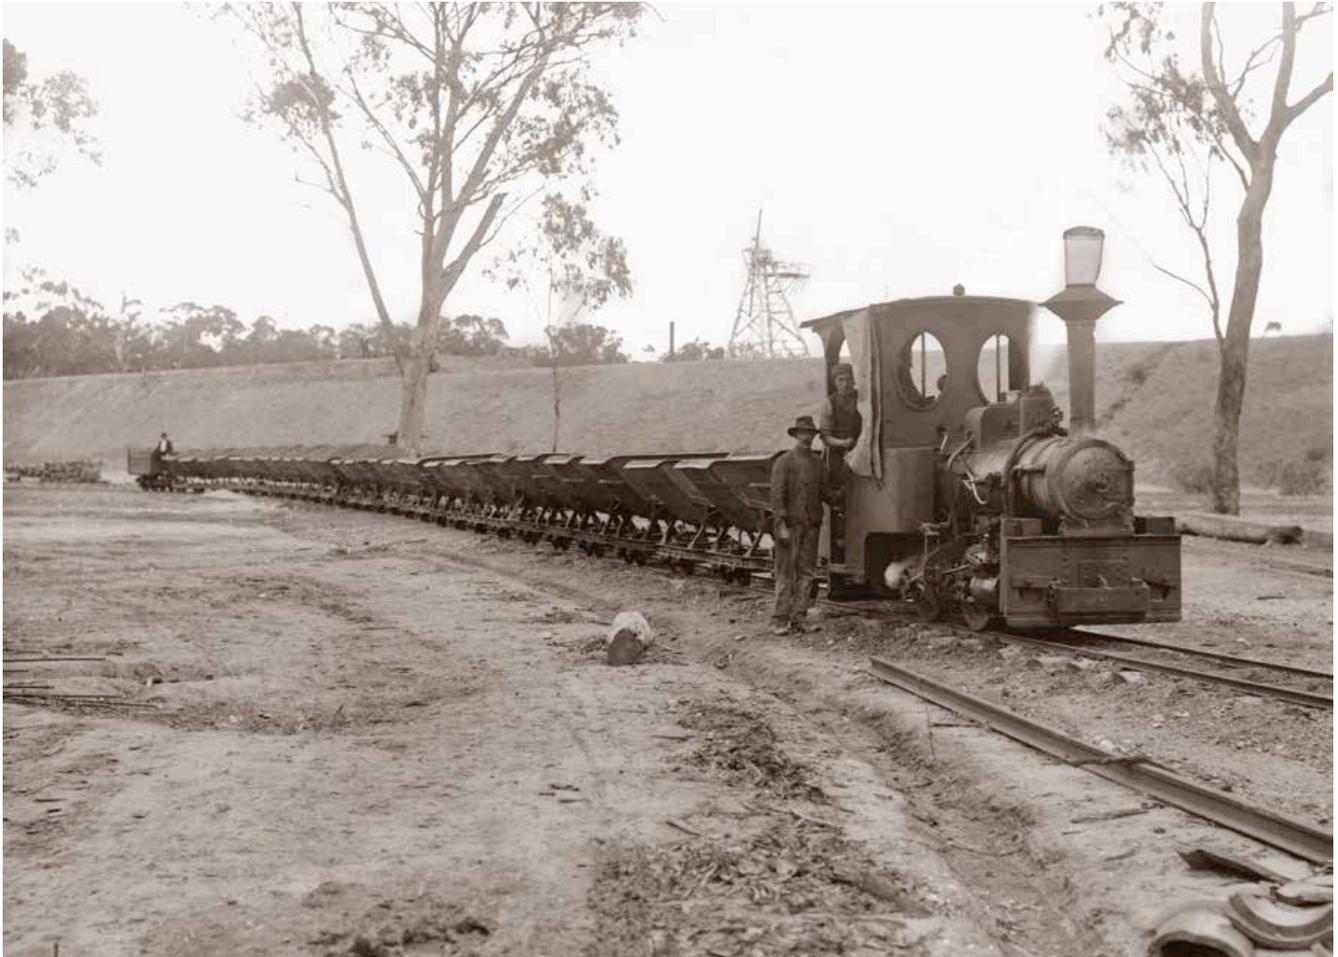
Krauss 0-4-0, B/N 2437 of 1891, Robin, returning from unloading fine sand, quarried from the bank of the Murray River, at Torrumbarry Weir and Lock construction site c1922. In the background, beyond the spoil bank, the radial tower, used to place concrete, is visible as is the 'guard truck', at the rear of the train. The occupant would assist with the shunting of trucks and the closing of gates along the way. Photo: State Library of Victoria

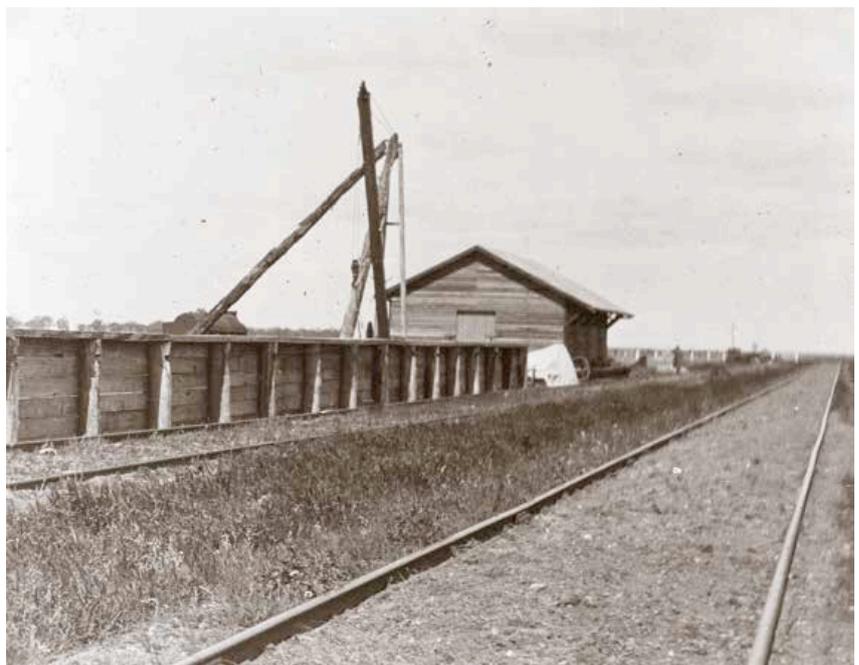
Torrumbarry Weir Siding c1921. The wooden barrier on the left kept the Carisbrook gravel from fouling the railway siding. A Priestman Grab (out of site to the left) was used to unload gravel from the railway trucks and place it on piles awaiting despatch by tram to the weir site.

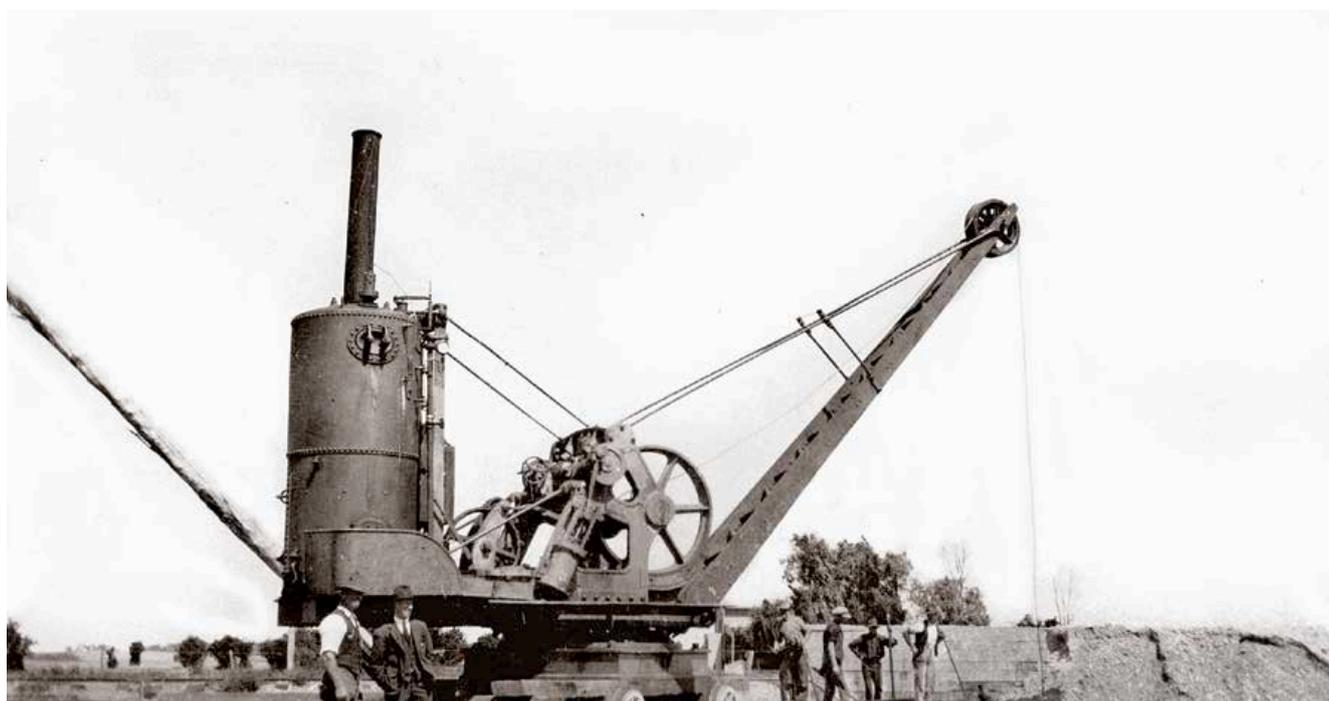
The Priestman Grab at Torrumbarry Siding 1922. Unfortunately, the photographer's aim was not what it could have been! The grab was self-propelled and travelled on its own rails. The pile of Carisbrook gravel is visible at the right, as is the protective wall beside the railway siding.

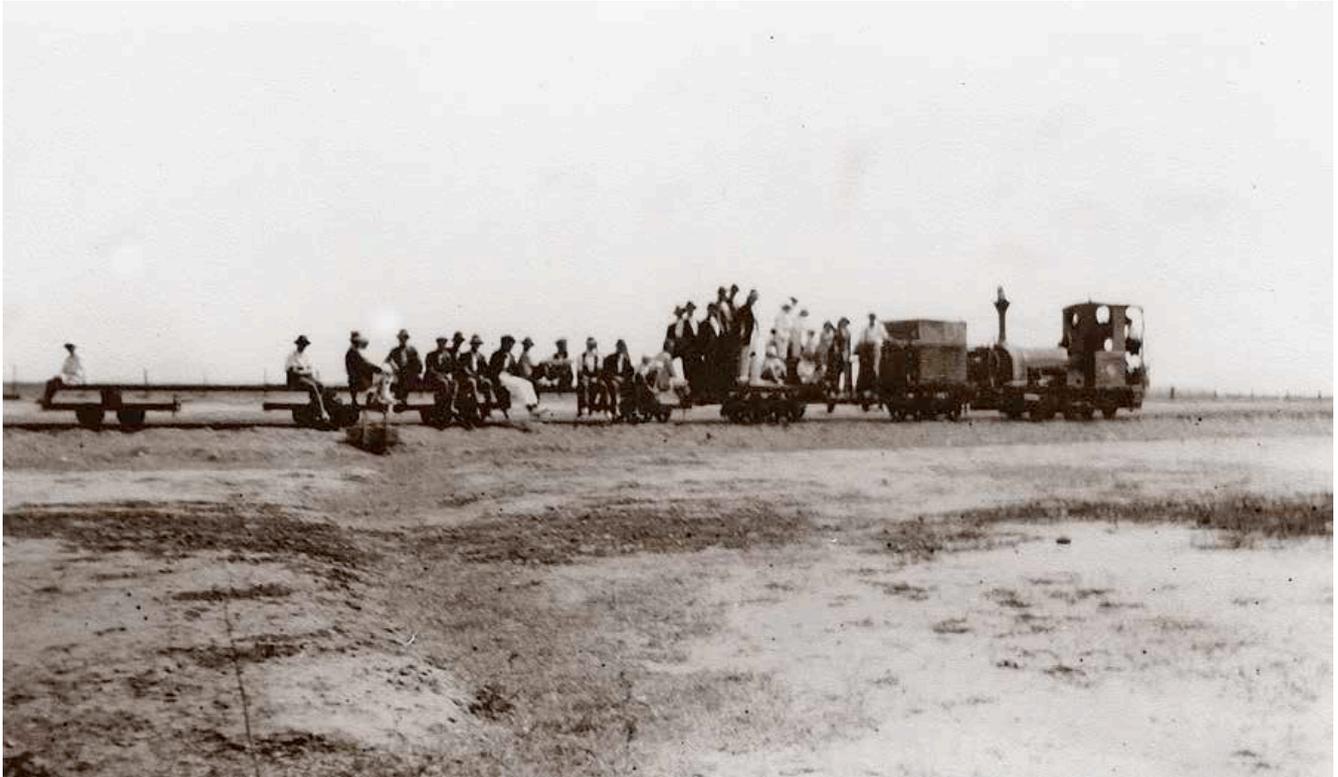
Black Hawthorn 0-4-2, B/N 1134 of 1897, Julia, is approaching Torrumbarry Weir Siding with a healthy load of passengers. The two rearmost bogie trucks were constructed upon tippler frames and were used for firewood transport and for the carriage of large items of equipment to and from the weir. Clearly, they also provided passenger accommodation when needed! The front two trucks featured larger diameter wheels and were used for general goods and as water tenders, as is evident in this image. Photo: Cohuna and District Historical Society

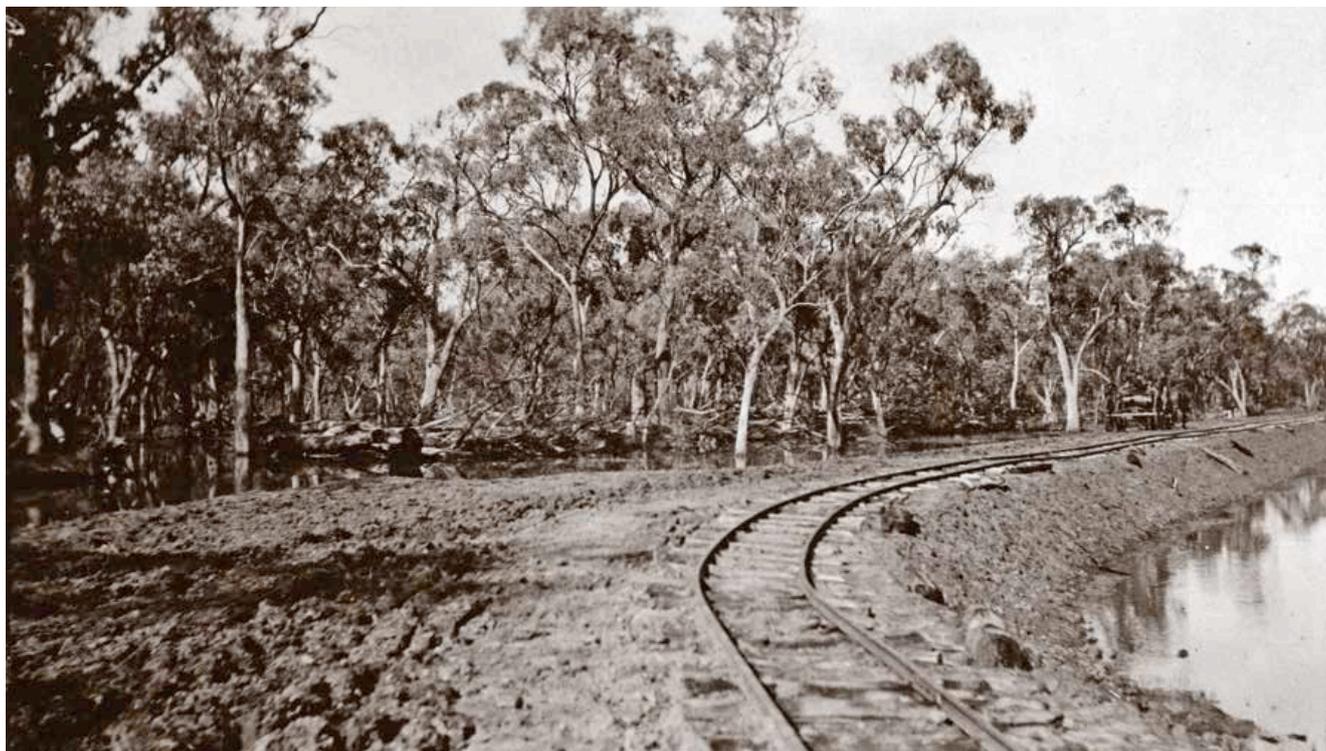
Probably taken on the access road to the weir (now Torrumbarry Weir Road) in 1920, not long after the tramway was completed and before gravel traffic commenced. The absence of any packing of the embankment made for a rough trip due to the uneven track. Photo: State Library of Victoria

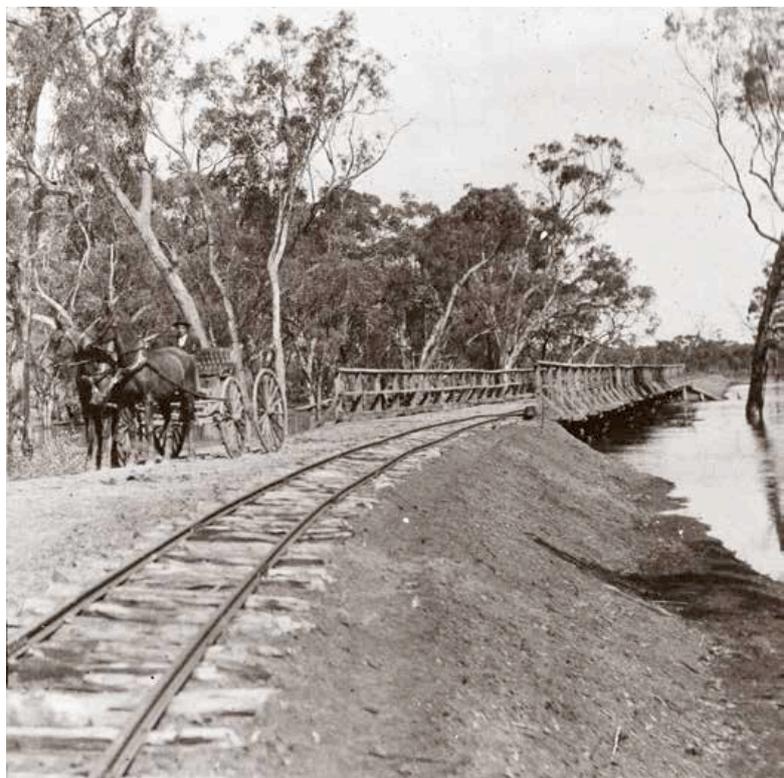
The only substantial structure constructed to accommodate the tramway was found around two kilometres from the construction site. The bridge over Cameron Creek was built to provide long term road access to the site. The flood prone country close to the weir site made necessary the use of a long embankment to carry the tramway and road until the protection levee was reached about a kilometre north of this location. The rough-hewn sleepers and light rail were typical of most weir construction tramways. The absence of spilt gravel suggests a date around early 1920, soon after construction of the tramway was completed.

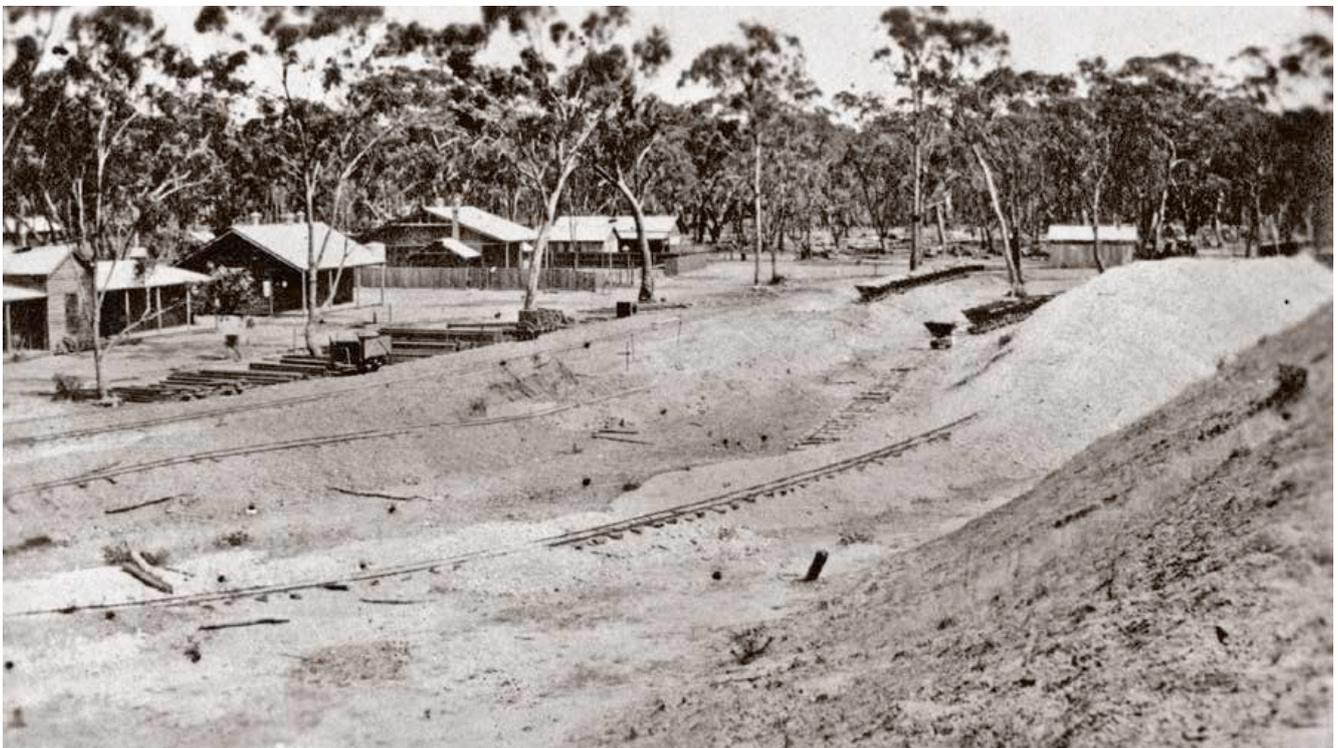
The sand and gravel dump site at the weir c1922. From the left can be seen the barracks, offices and houses for senior officials. The store yard for rail and construction timber was served by a siding, marked here by the small open wagon stored there. To its right is the main access tramway which travelled around to the hoppers, firewood mill and cement stores. Further to the right are the sidings serving the fine and coarse sand heaps and, evident by its lighter colouring, the Carisbrook gravel heap. The locomotive shed is visible at upper right. Photo: State Library of Victoria

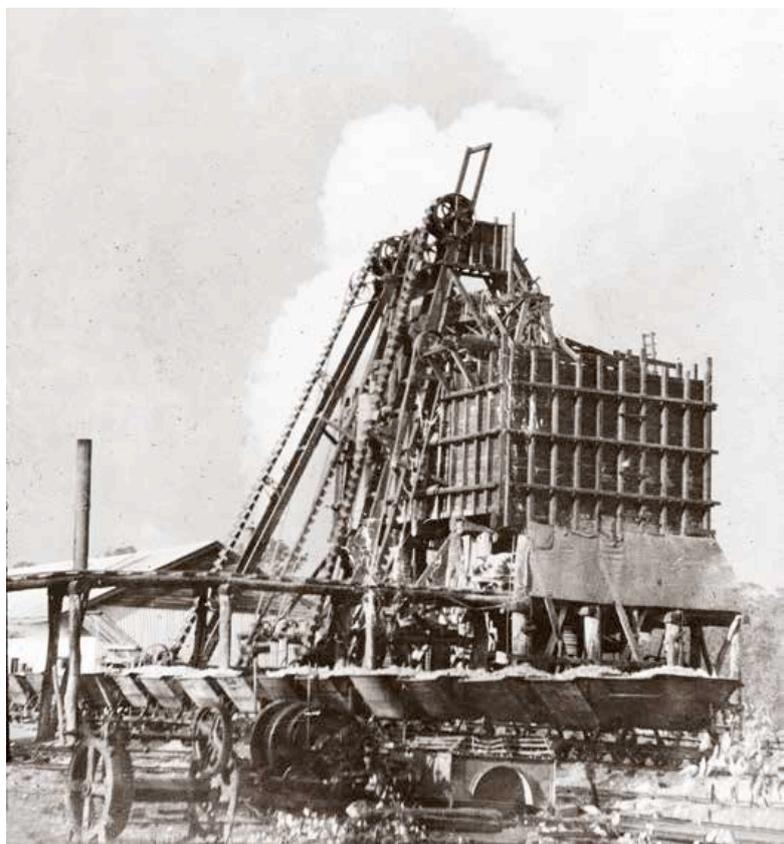
The sand and gravel hopper at the weir and lock site c1922. Originally there was a single conveyor to carry material to the rotary screen. As work intensified a second conveyor and dump point were introduced.

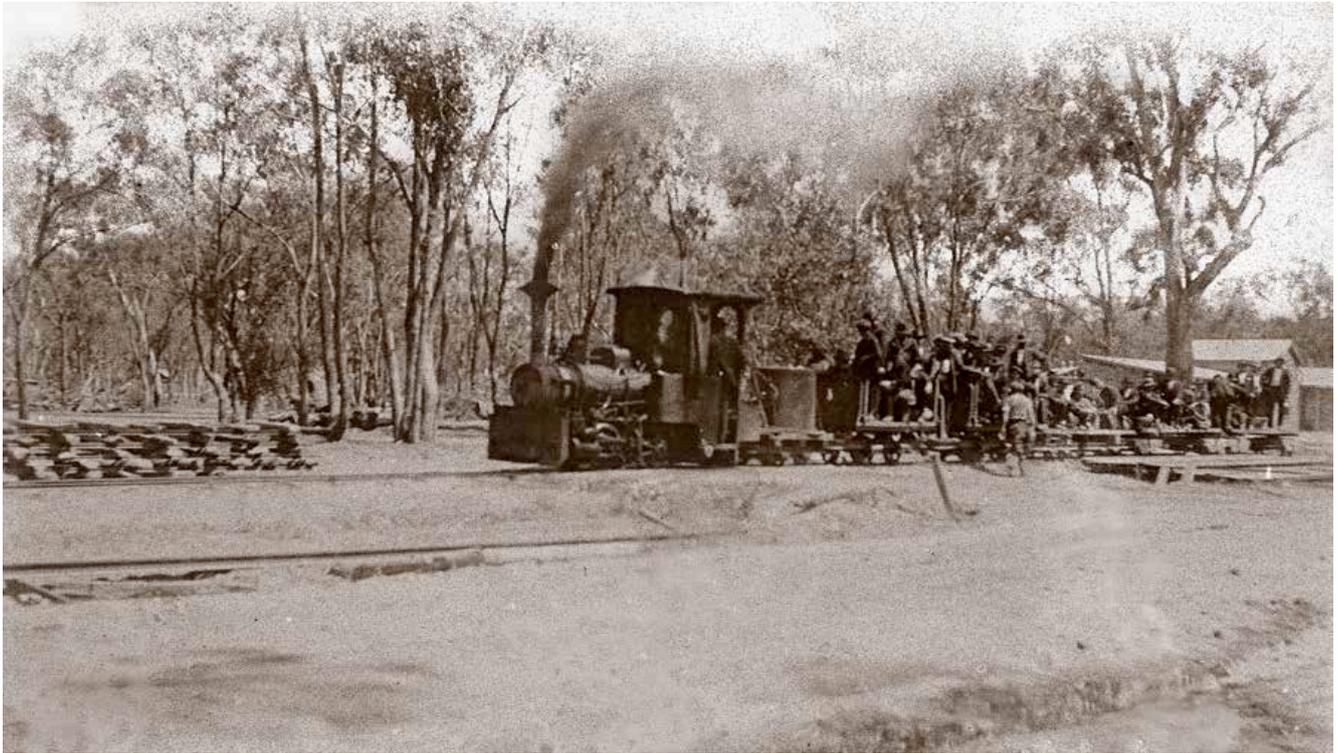
Another passenger train, this time hauled by Krauss, Robin, about to depart the weir site. The presence of a water tender behind Robin suggests that the railway siding was the destination. The Krauss was mostly used on short haul runs and did not usually make use of a tender.

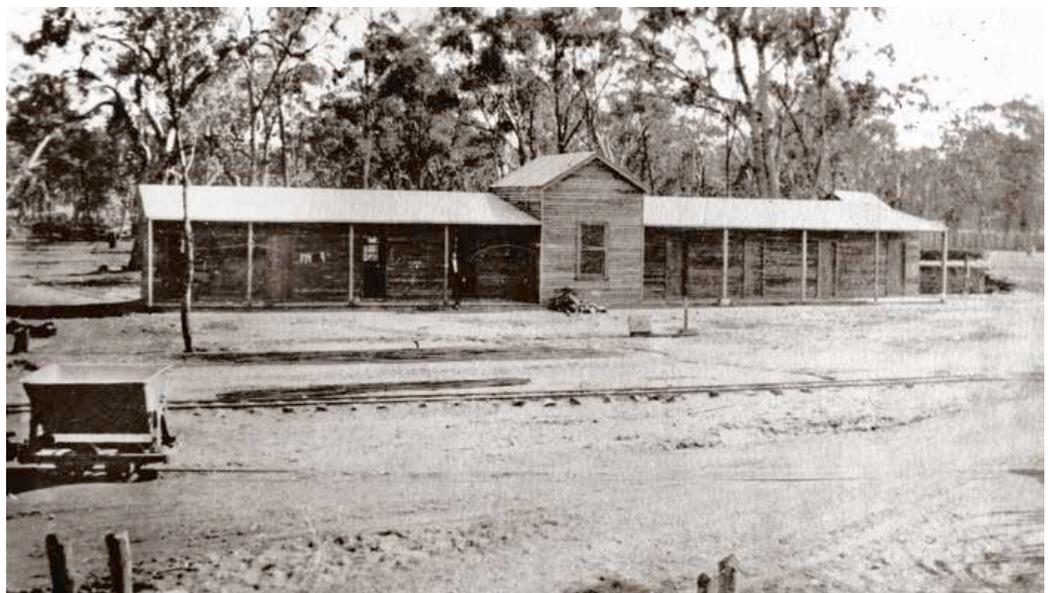
The officers' barracks at the weir site c1922. In the middle ground the main tramline to the hoppers, stores and workshops is visible while in the foreground the siding that served the sand heaps can be seen.

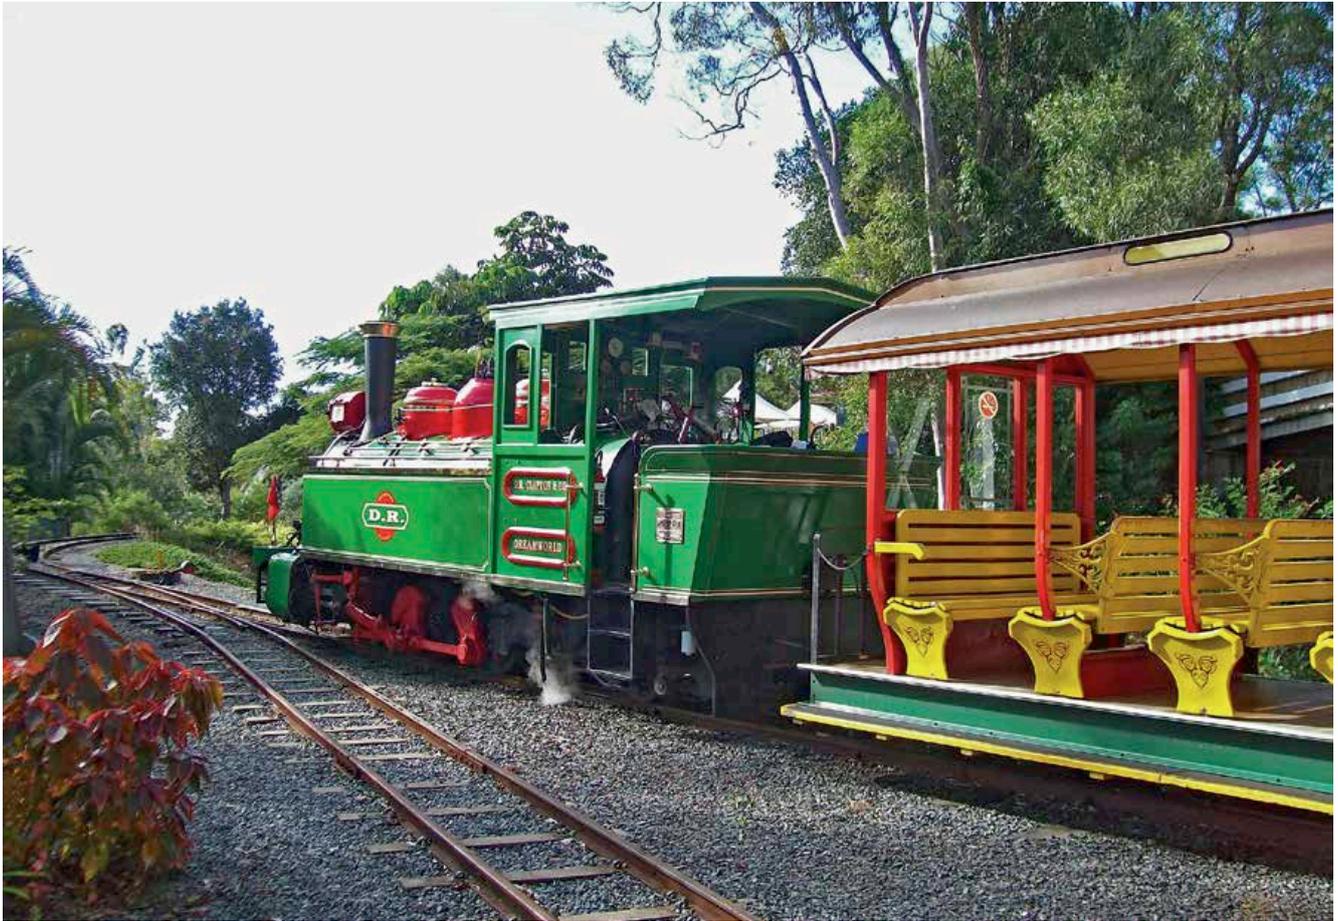
The Perry is ready to depart the Train Shed for the day's run. Notice construction of the carriage – an excellent copy of the carriages at Disneyland except for being 2 feet gauge instead of 3 feet.

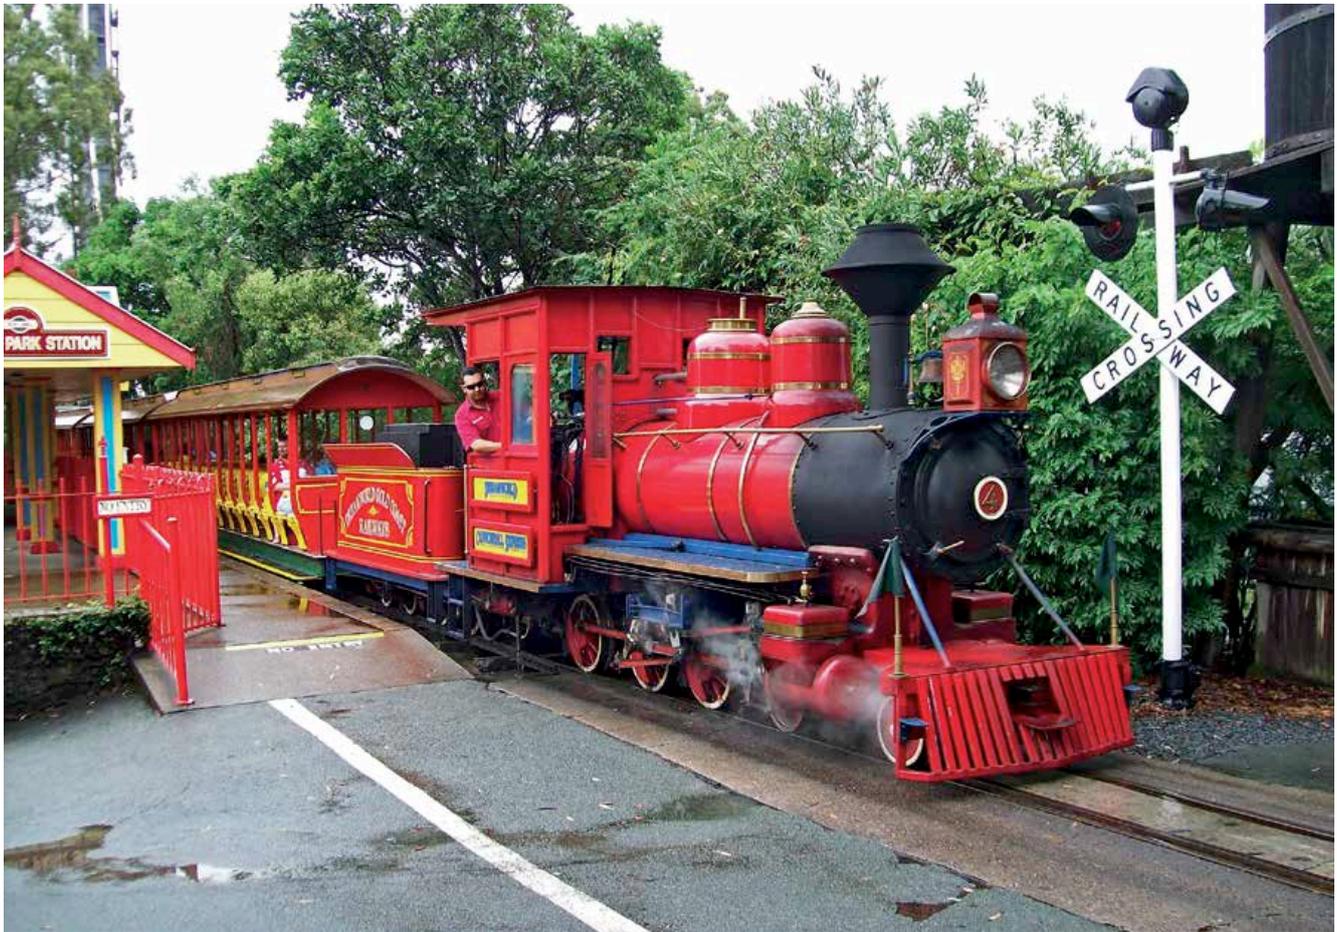
*The Baldwin departing Central Park Station. The crossing sign, flashing lights and bell can be seen clearly, warning pedestrian traffic at the crossing.
Photo: Teddy Hancox*

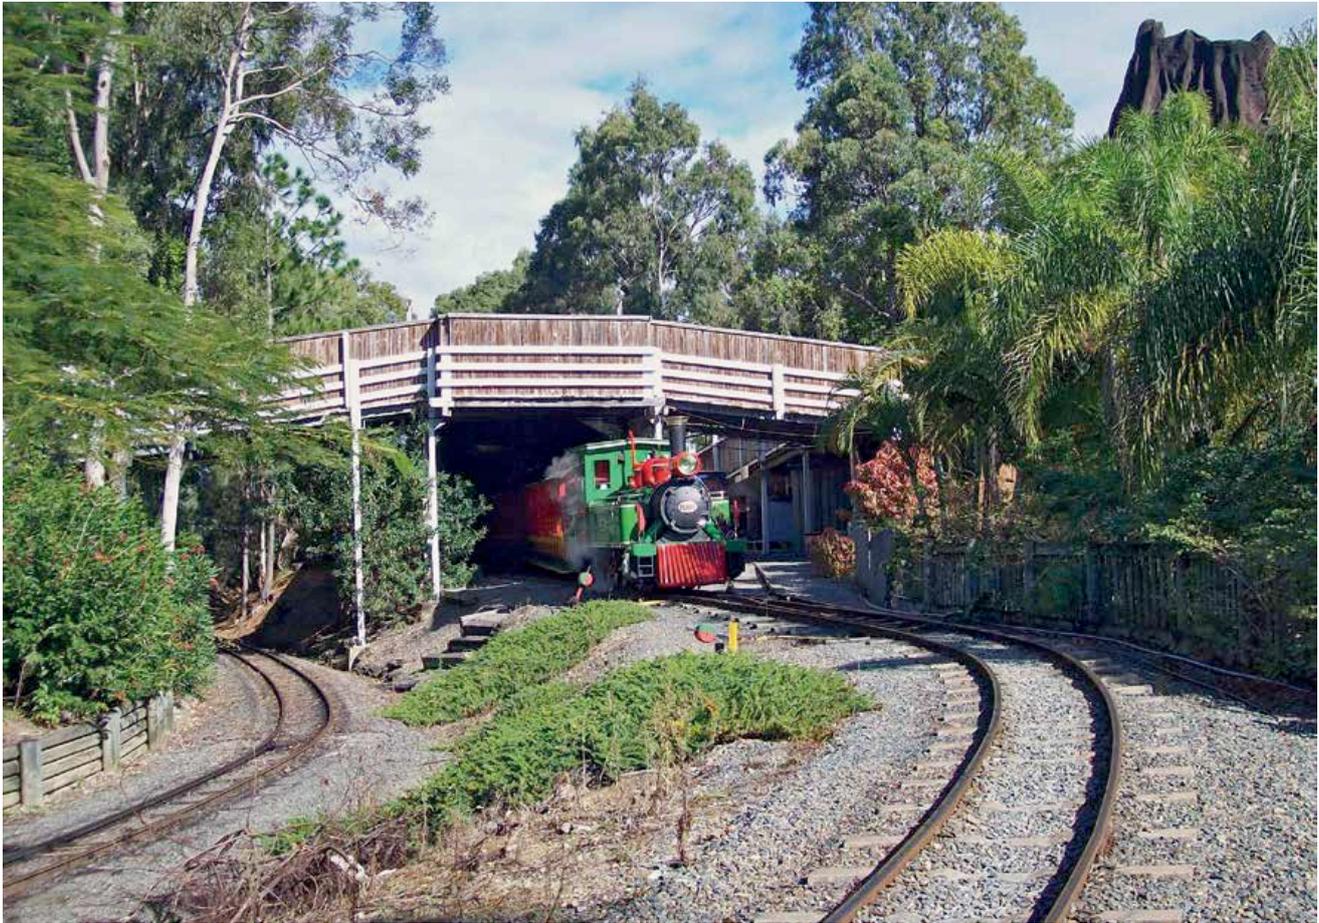
The scene approaching the Train Shed set in a secluded part of the grounds. The track to the left, at a lower level, is the main line at the top of the 1 in 40 climb, on a 15 metre radius curve.
Photo: Teddy Hancox

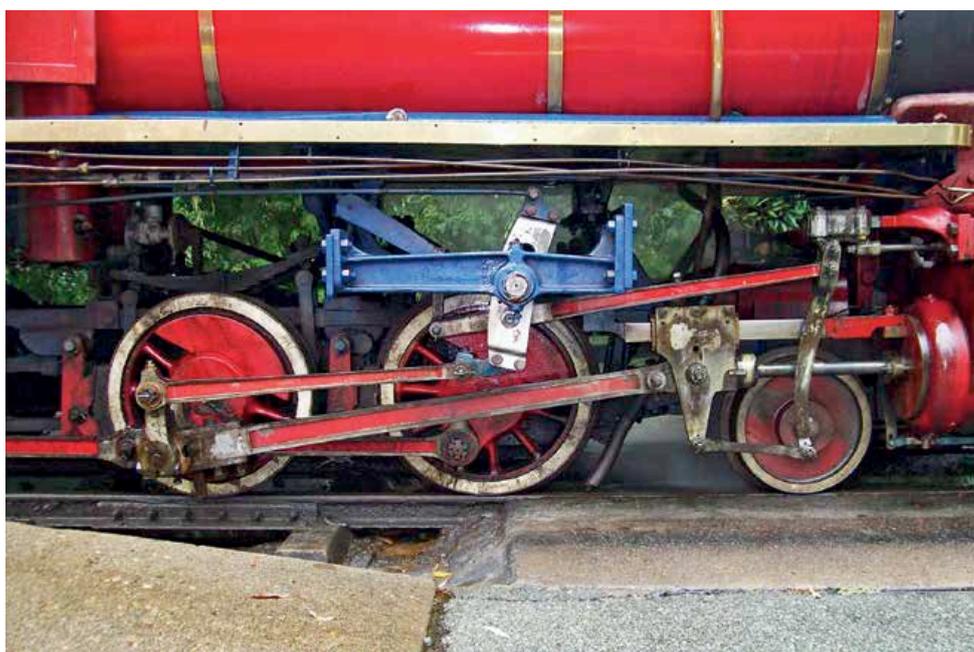
*Nicely proportioned and fluted rods of the Baldwin’s Walschaerts valve-gear. A nice touch on an engine that was not expected to survive more than a minimum of years in gruelling war-time situations.
Photo: Teddy Hancox*

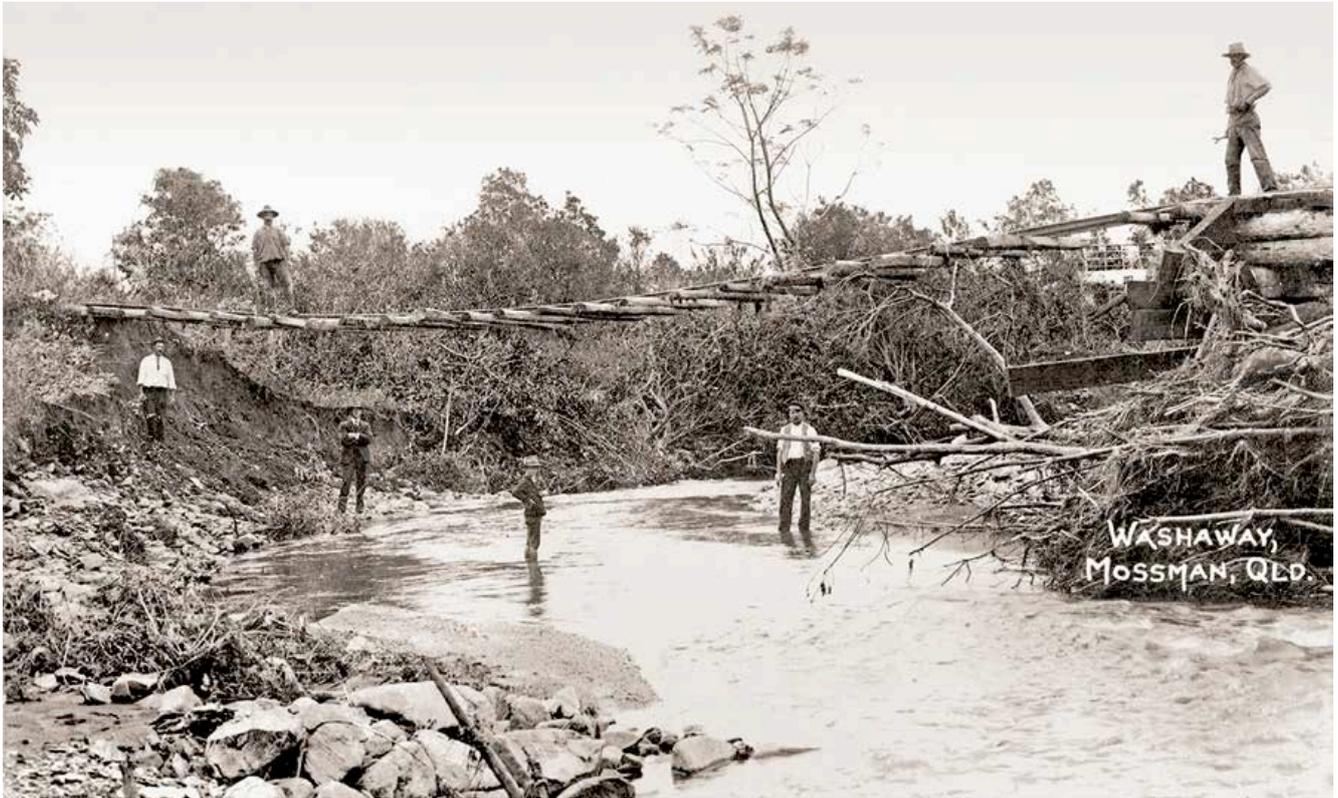
The first image (above) is of a tramway bridge washaway on the Mossman Mill system following a flood. It shows the track still in place, the sleepers being sawn logs, while the bridge itself has disappeared. The scene may well illustrate the devastation of the cyclone of 16 March 1911. It may be that referred to here: "The tramway bridge at Reynolds' deviation on the Mowbray line, constructed about a couple of years ago under the superintendence of Mr. E. Harvey Gibbon, Shire Council engineer, is stated to have been swept away."

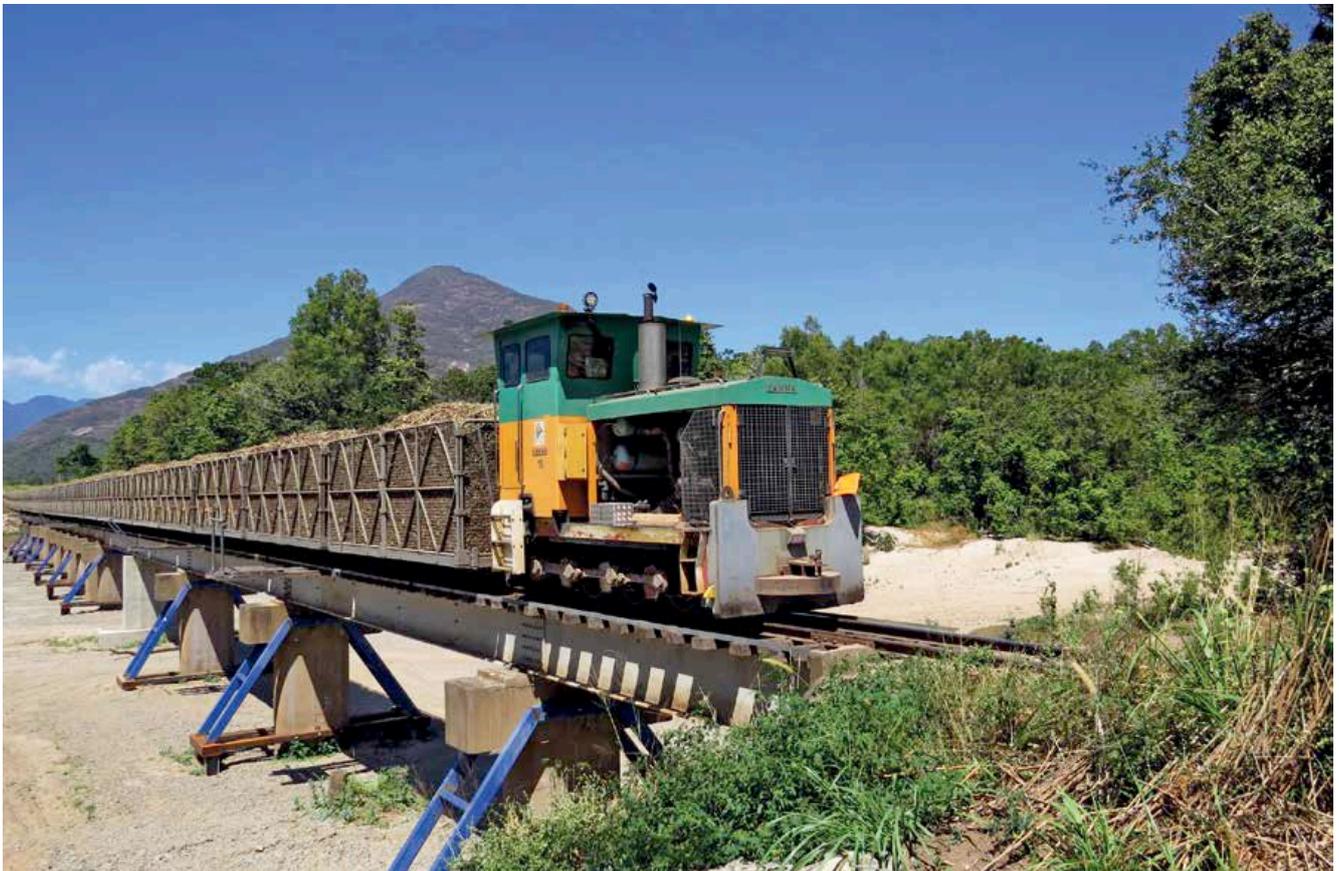
Mulgrave Mill Clyde 0-6-ODH 16 Kamma (56-96 of 1956) passes over the strengthened Mulgrave River bridge on 1 September. Photo: Gregorio Bortolussi

August. By September, Com-Eng 0-6-ODM 5 (A1005 of 1955) had been placed beyond a bridge over a small creek on the Meerawa branch. The bridge is closed to locos and 5 is used to move bins around when a harvester is working in the area. New 6 tonne bins destined for this mill or South Johnstone Mill were seen being placed on the track outside the Bradken Boogan factory on 24 August.

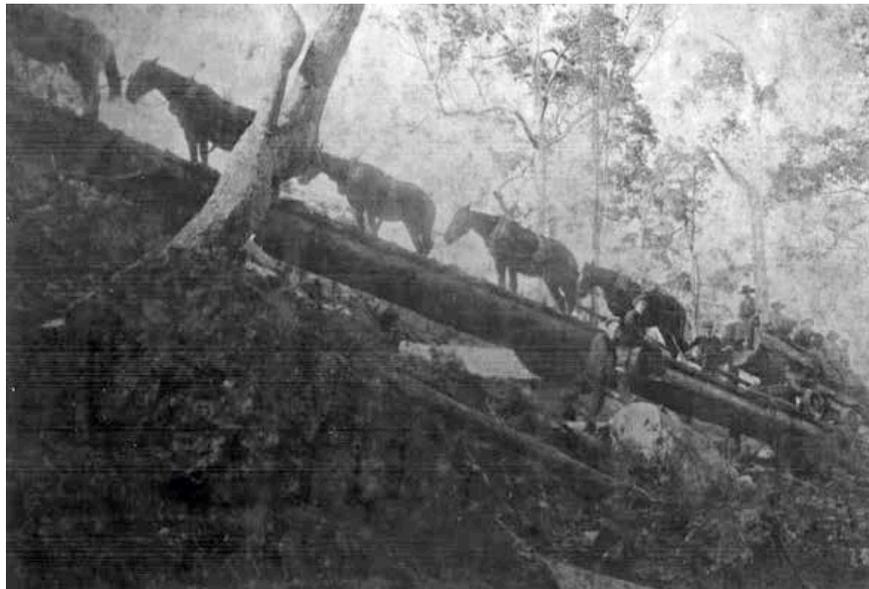
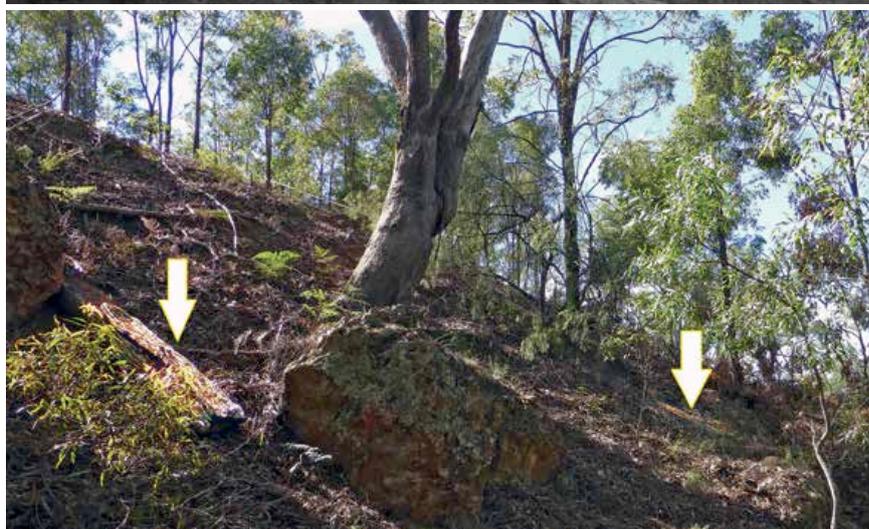
Image 1: A horse team hauling a three-ton log on the Cabarlah tramway (from a photograph taken by Trilby Studios in 1896), and the possible site of that bridge. Two pieces of timber (arrowed) have one side hewn flat, and may possibly be remnants of that bridge. (Photograph by Alan Bryce).

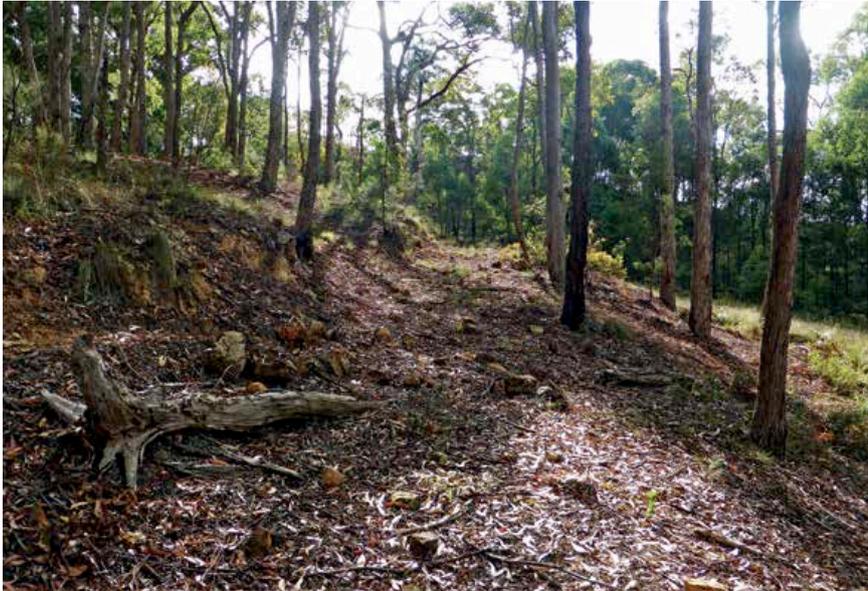
Image 2: A side-cutting on the Cabarlah tramway. (Photograph by Alan Bryce).

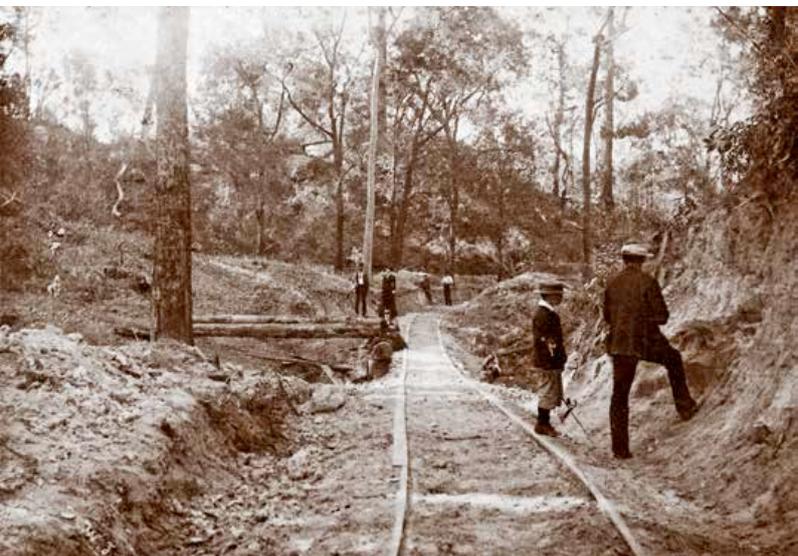
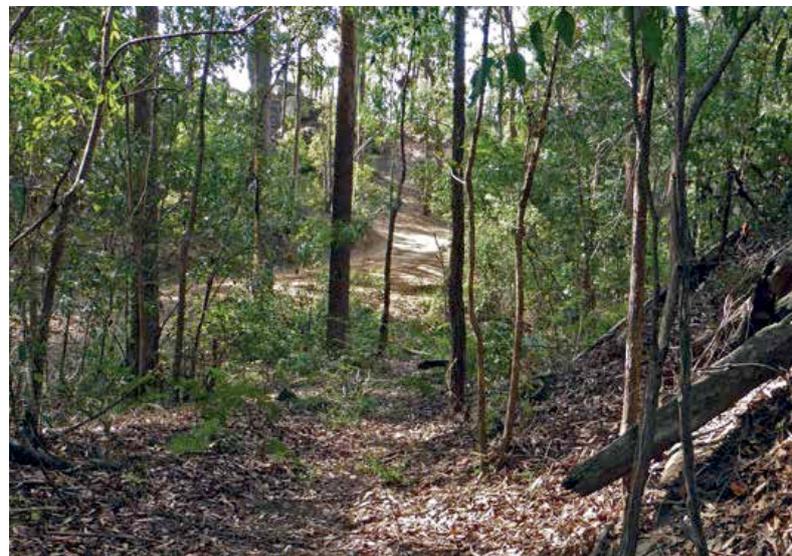
Image 3: Comparison of photographs taken 120 years apart: in the late 1890s and in April 2018. The sites appear almost identical, with a gully running from left to right across the centre of frame and a distinctive rock formation (see comparison) in the far distance. These photographs tend to confirm that this is indeed the Cabarlah tramway. (Photographs courtesy Munro family and Alan Bryce).

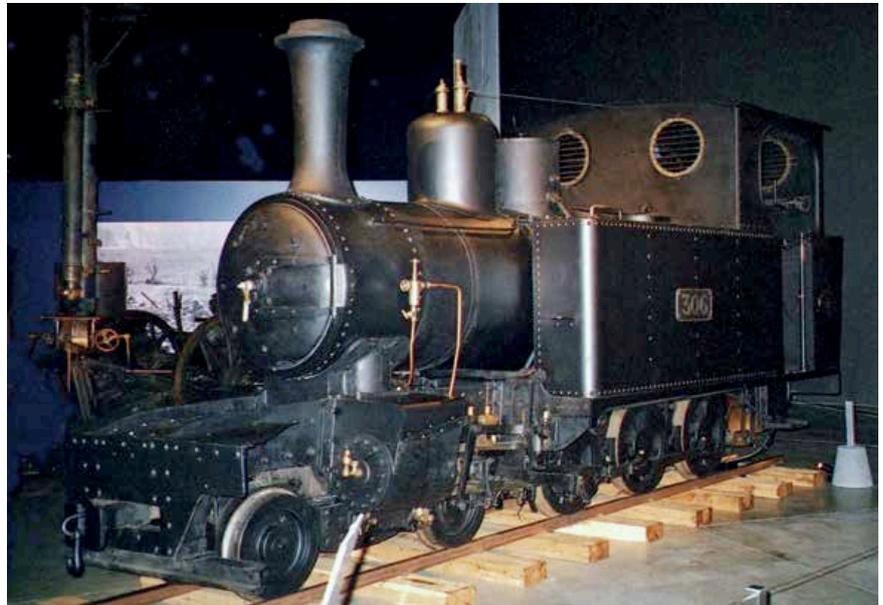
Hunslet 4-6-0T ROD 306 (Bn 1218 of 1916), ex Gin Gin No 1: cosmetic restoration on display at the Australian War Memorial May 2005. Photo: Ian Bevege

these U.K. Hunslets, two war surplus narrow gauge (600mm) American Baldwins, a 4-6-0 loco Bn 45215 of 1917 (Racecourse No.5) and a 2-6-2T Bn 46828 of 1915 (Fairymead *Felin Hen*), also found their way to the canefields. A number of the Hunslets are now static displays in various locations, but three of them and the two Baldwins have undergone or are undergoing restoration to full running order; the exception is Hunslet ROD 306 (Bn 1218 of 1916, Gin Gin No.1), which has had a cosmetic restoration only and is on display at the Australian War Memorial². An account of these WW1 canefield locos is in preparation.

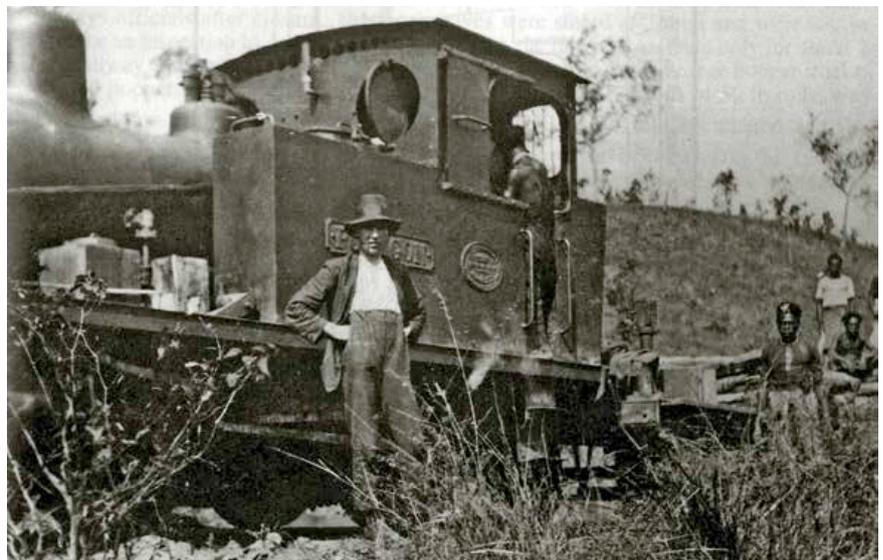
Barclay 0-6-0T Polygon in Papua, c.1921. McKillop and Pearson 1997 photo with permission from Bob McKillop.

published build dates variously as 1918 and 1919³. However, the four locos were named by BHAS after Western Front battlefields in honour of the Australian troops who fought there: *Pozieres* (Bn 1543 of 1918), *Polygon* (Bn 1544 of 1918), *Peronne* (Bn 1545 of 1918) and *Passchendaele* (Bn1546 of 1918).

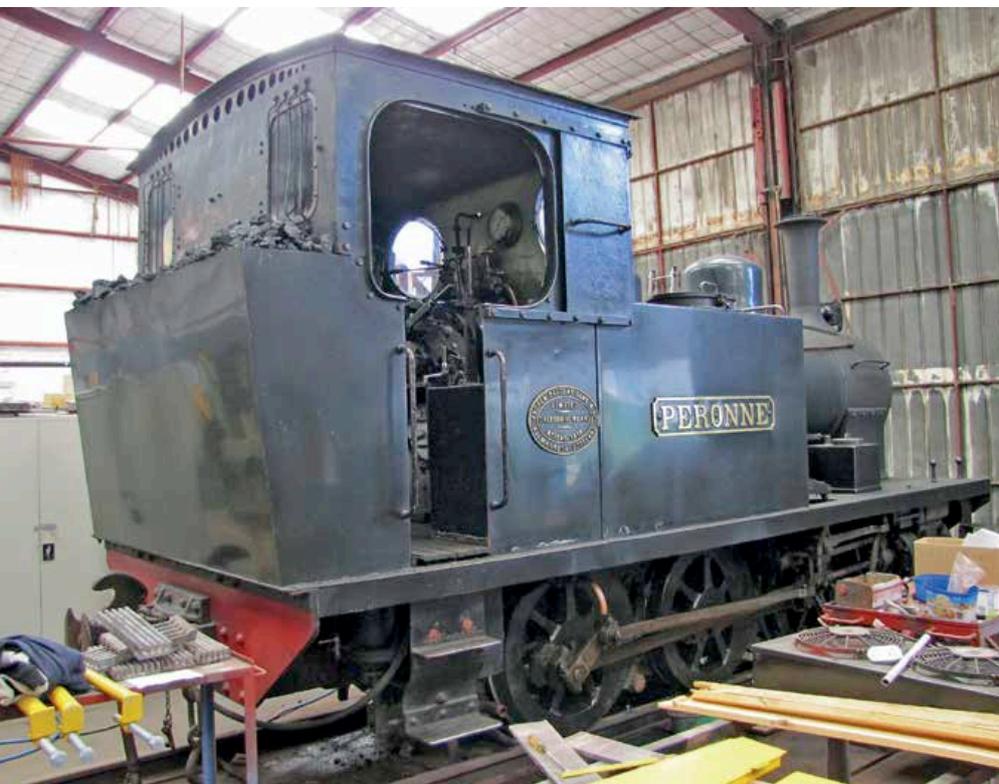
Former Broken Hill Associated Smelters (BHAS) 0-6-0T steam locomotive Peronne was built by Andrew Barclay (No.1545) in Scotland in 1919. It was withdrawn from service with BHAS at Port Pirie in 1964, and arrived at the Mile End Railway Museum in February 1966. It was completely restored by the Mile End Railway Museum, and was relocated to Quorn and recommissioned on Pichi Richi Railway in May of 1988. Following tests and crew training, it was relocated to the NRM in November 1988, in readiness for the official opening of the NRM on 10 December 1988.

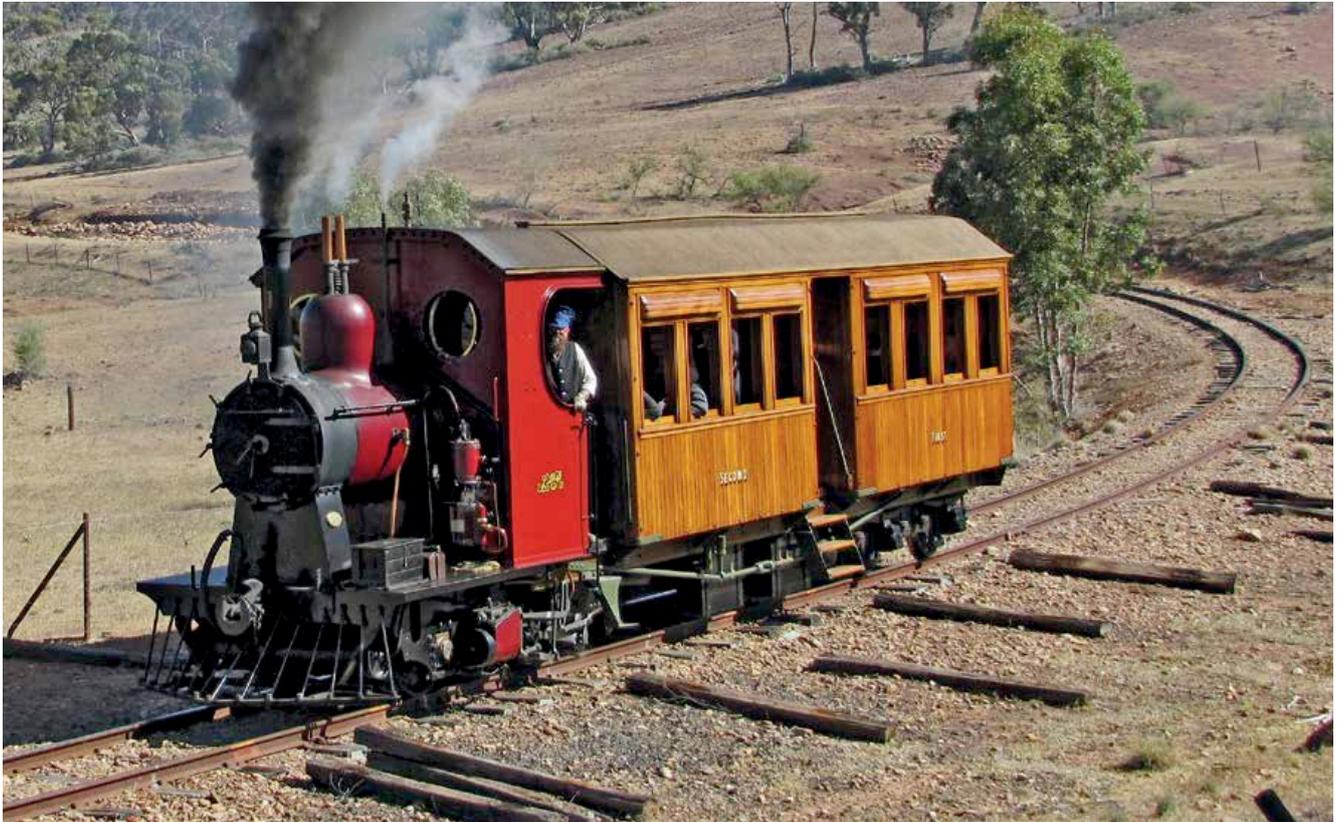
The unique Pichi-Richi Railway Coffeepot, shown approaching the road crossing near the summit, was acquired by the SAR in 1906 as Steam Motor Coach No.1; a 2-2-0WT, the engine unit was Kitson built 4356/1905, the carriage was from Metropolitan Carriage & Wagon Company. Taken over by the CR as NJAB1, it was withdrawn from service in 1932. It was refurbished externally in the late 1950s and transferred to Alice Springs for display by the National Trust. In 1973 it was acquired by the PRRPS and restored to working order by 1984, and ran into the 1990s until the boiler needed work. It was returned to service in 2016. Photo Michael Chapman
