LIGHT RAILWAYS

Australia's Magazine of Industrial & Narrow Gauge Railways

No 264 December 2018

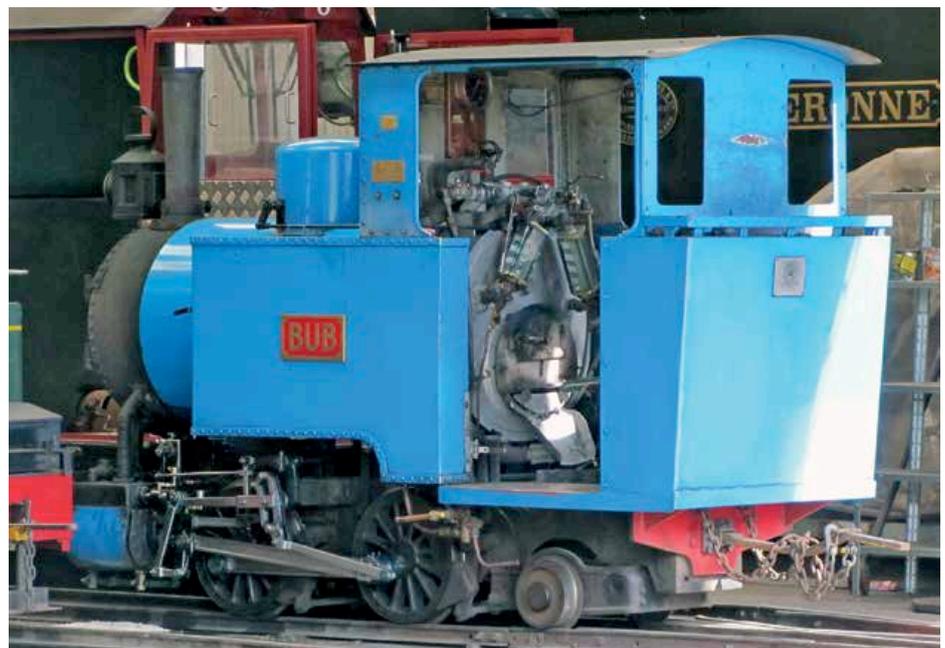
The 0-4-2 steam locomotive No.4, is named Bub and began operations at Port Dock in late 1988. It was designed and built by volunteers at the then Mile End Railway Museum over a period of several years. It has operated over the Semaphore to Fort Glanville Railway for a few seasons. Photo Michael Chapman

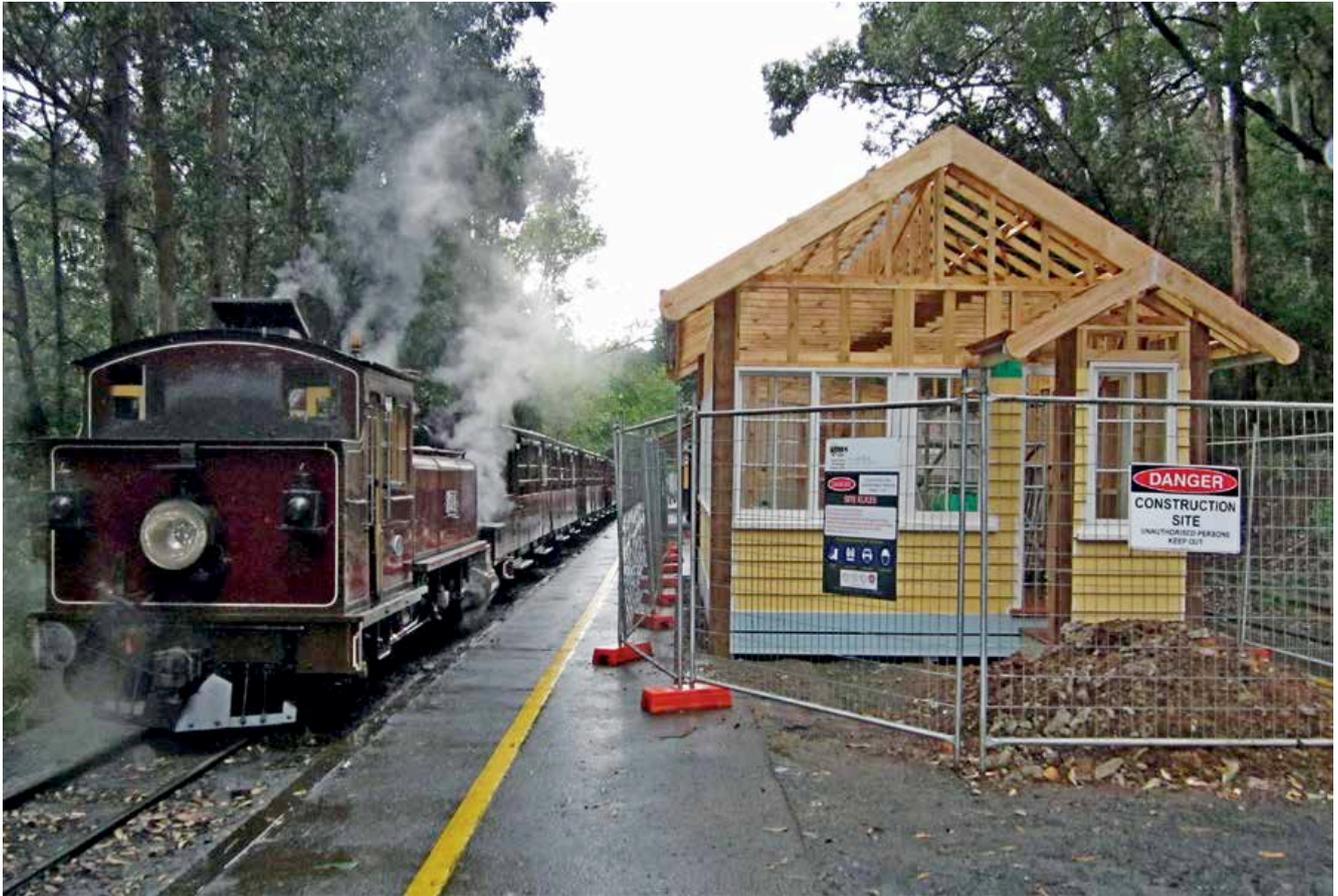
Above: The new signal box at the Puffing Billy Railway's Lakeside station in an advanced state of construction, 2 November 2018. Locomotive 12A waits to depart on the 1.30pm train to Belgrave on a wet Friday afternoon. Photo: Phil Rickard

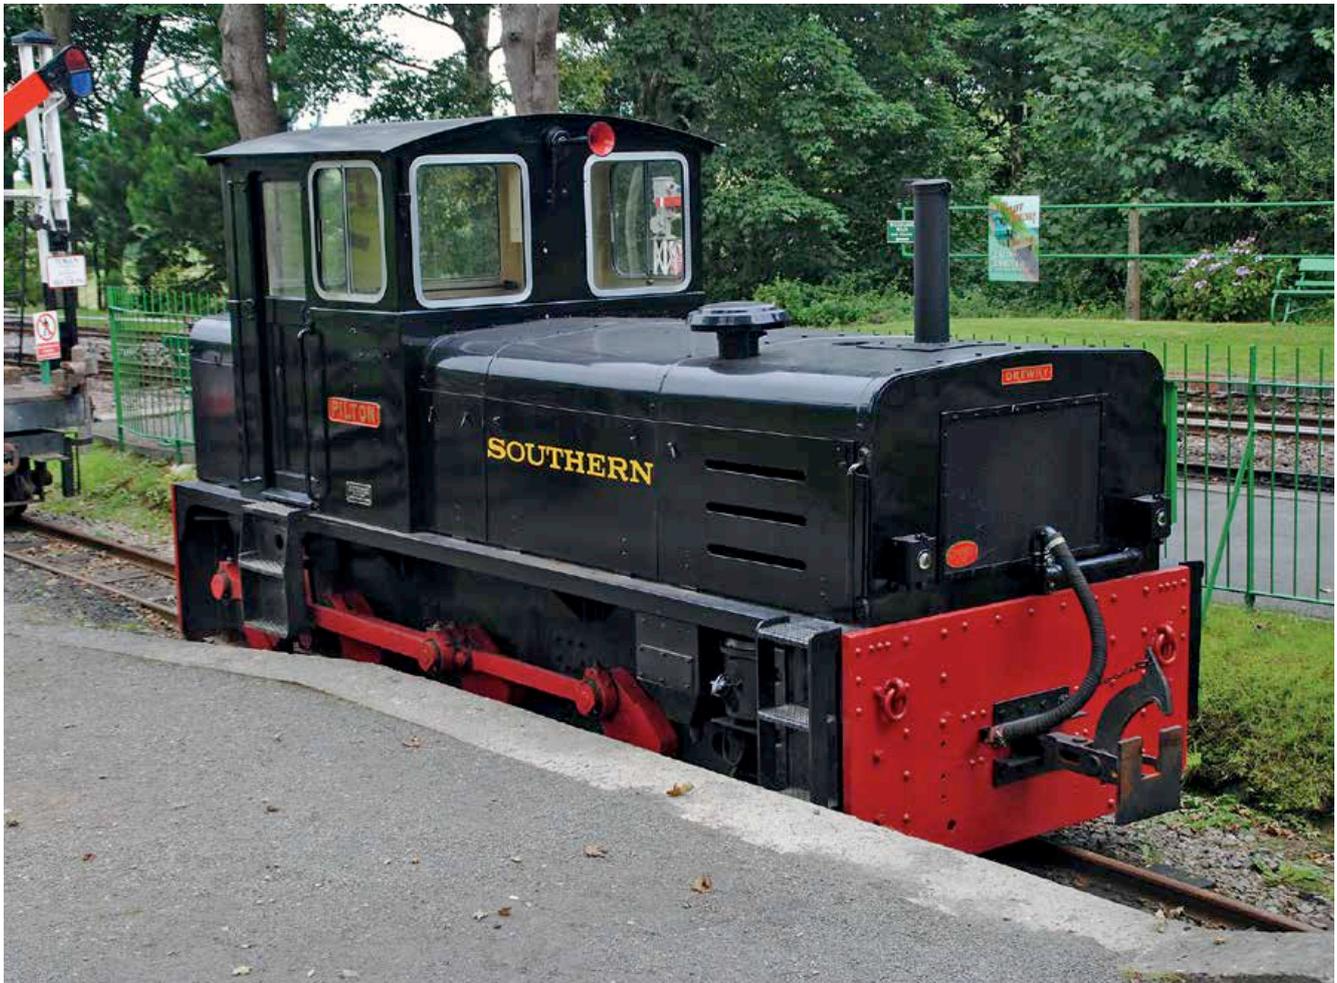
Ex-Victoria Mill Baguley/Drewry 0-6-0DM Pilton at the Lynton & Barnstaple railway in the UK.
