# LIGHT RAILWAYS

Australia's Magazine of Industrial & Narrow Gauge Railways

No 229 February 2013

Restoring <i>MOURILYAN</i> .....	3
Fractures and failures.....	10
Little Tableland and the South Johnstone multi-twins.....	18
Industrial Railway News.....	20
Letters.....	26
Research.....	28
Field Reports.....	30
Heritage & Tourist News.....	34

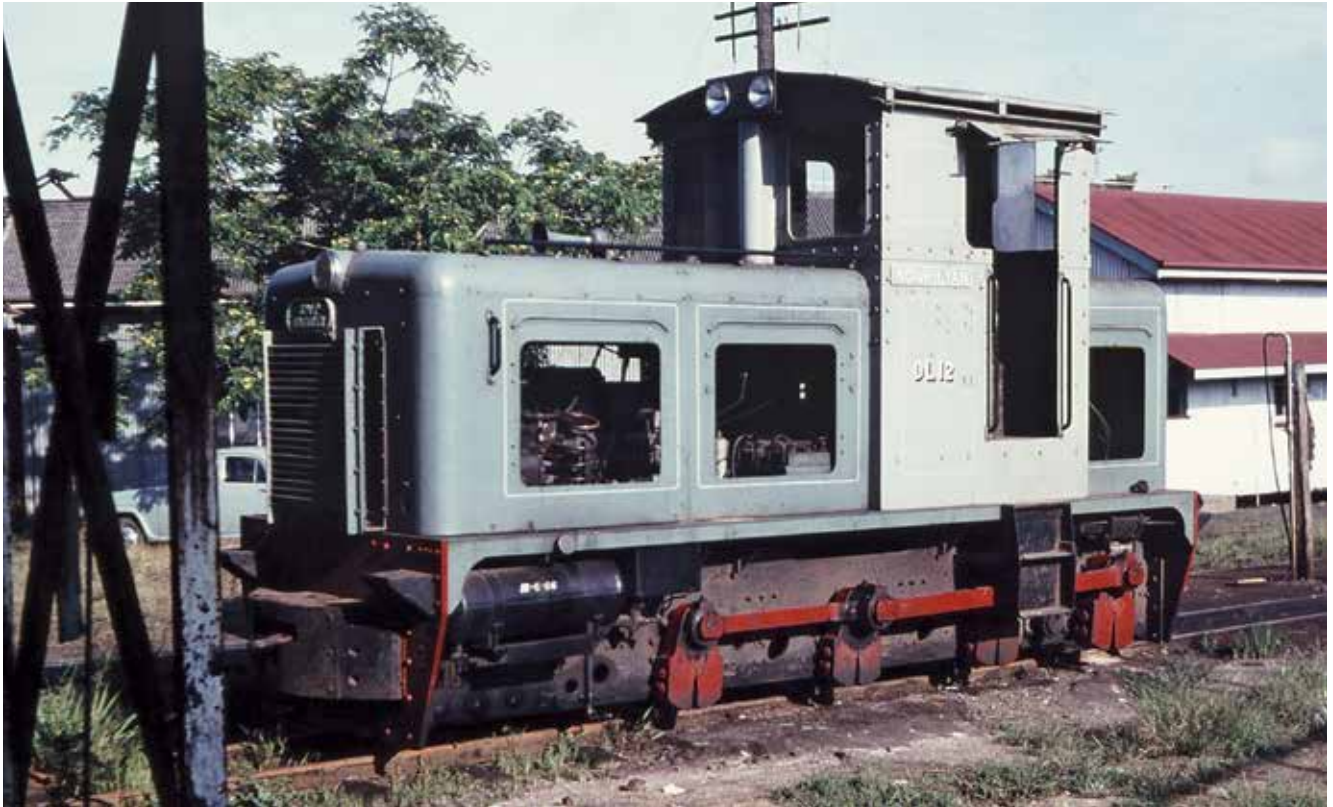
*DL12 MOURILYAN at Mourilyan Mill on 15 November 1966. The engine bay door panels have now gone, extra headlights have been added and the tropical Queensland sun has bleached the locomotive's original royal blue paint colour.* Photo: Weston Langford

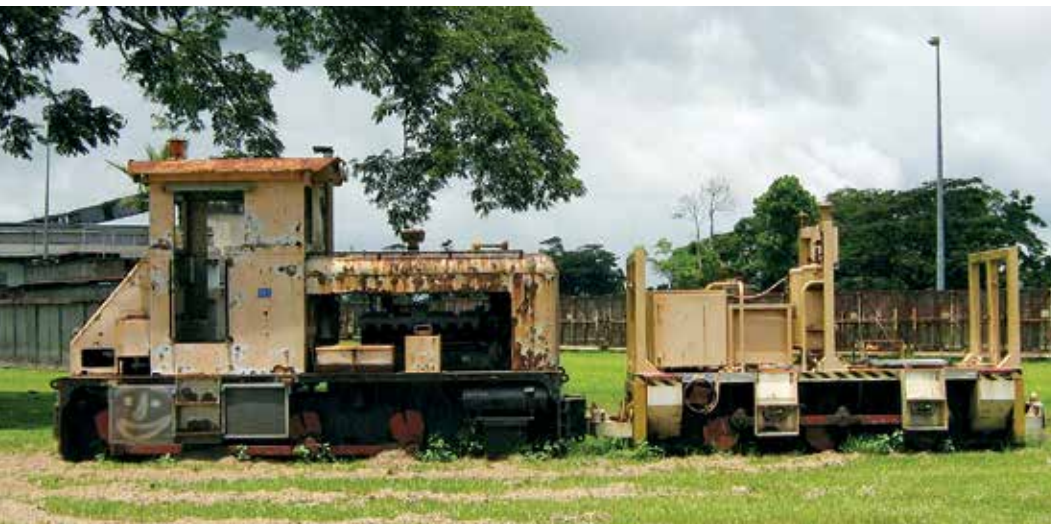
**Left:** In its final guise, as South Johnstone number 10, the former MOURILYAN sits out of use at the old Mourilyan Mill site on 3 February 2008. The brake wagon alongside began life as a diesel locomotive from the same builder, Drewry 2396 of 1952, ex-South Johnstone Mill number 14. Photo: Chris Hart

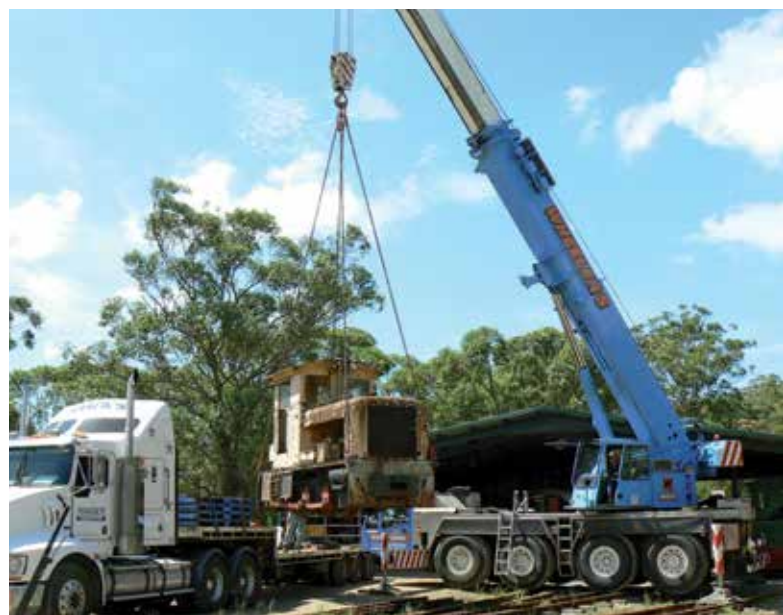
A very large road crane was called in when the loco arrived at Lake Macquarie Light Rail in February 2010. The crane crew certainly knew their job and the impressive capabilities of their computer-controlled crane. Within 30 minutes they had the diesel loco off the semi-trailer and onto a piece of temporary track. Photo: Ian McNeil

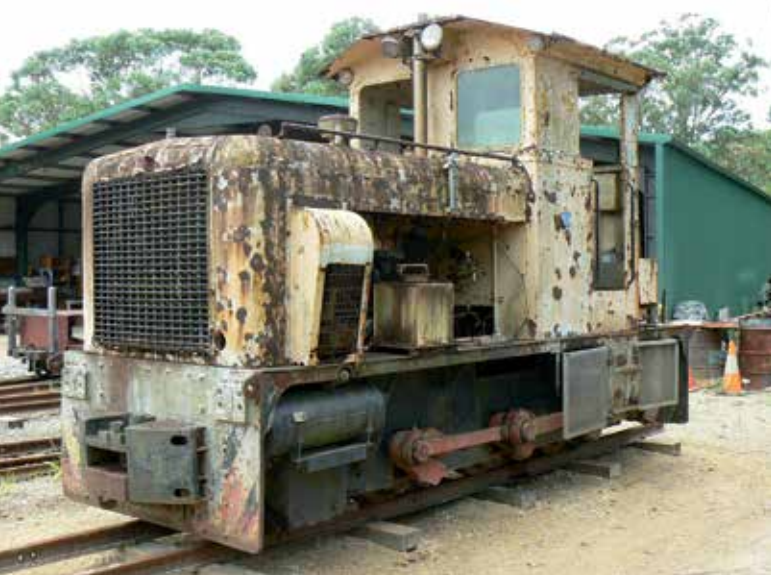
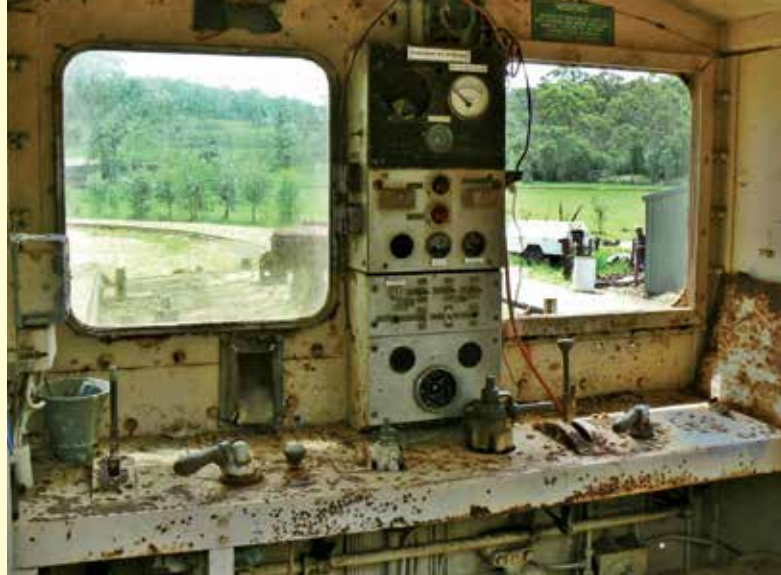
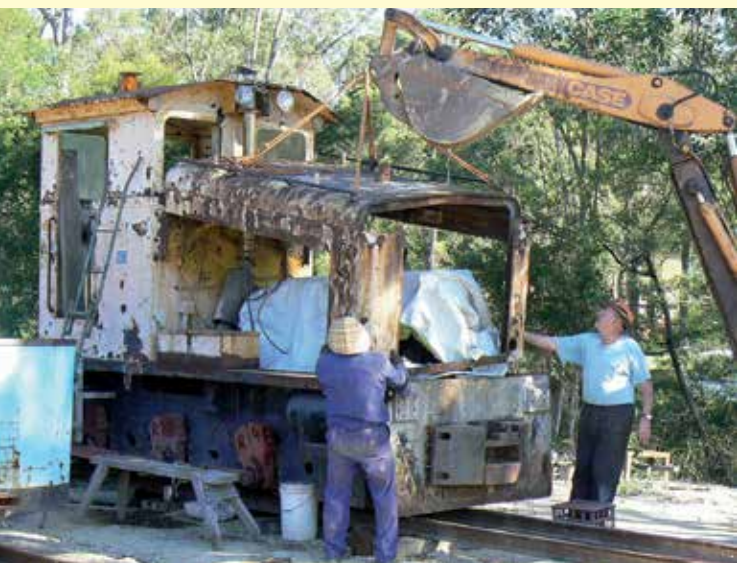
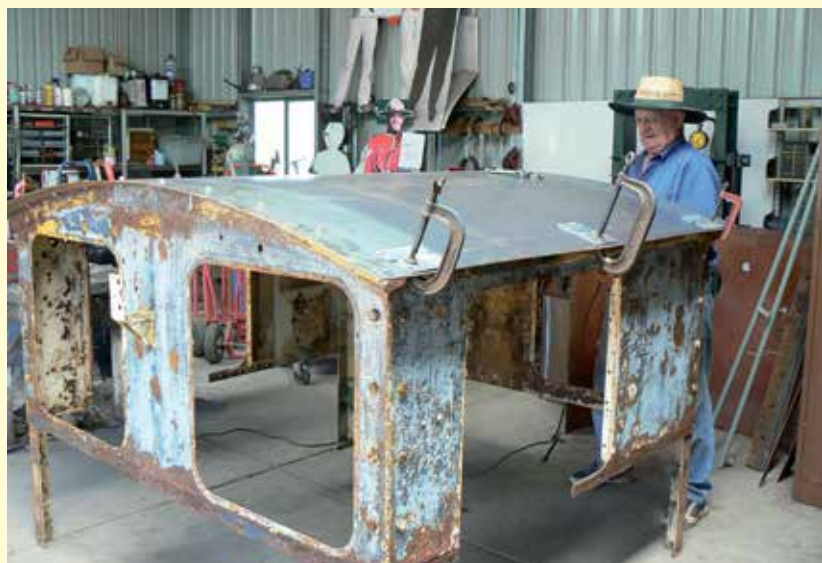
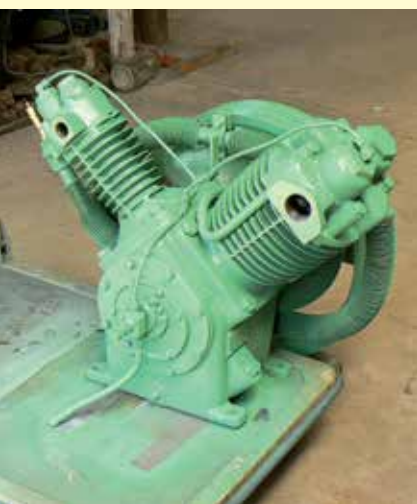
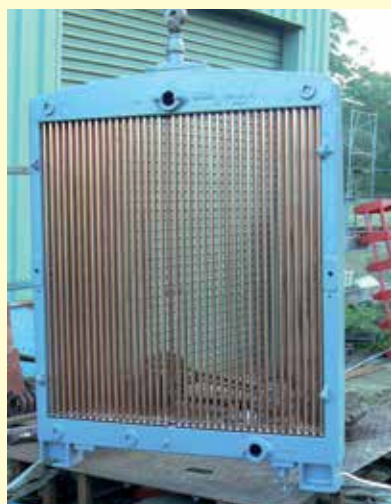
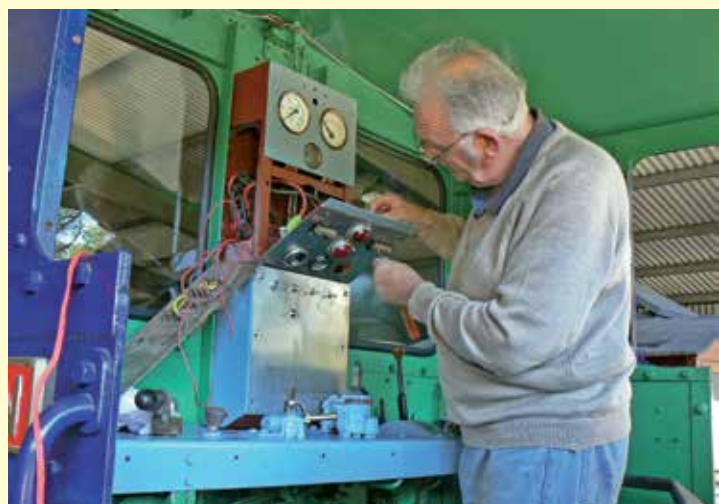
**From top left:** The loco newly arrived at Lake Macquarie Light Rail in February 2010. Faded paint and heavily rusted bodywork show that north Queensland's tropical climate has not been kind to the locomotive. • The cab interior was in a sorry state when the locomotive arrived. Restoring it back to original condition was a long and challenging process. • LMLR's 7-tonne backhoe was an indispensable aid during the dismantling process. Here MOURILYAN's front hood unit is lifted clear of the loco's chassis, en route to the workshop where it will be completely rebuilt. • A replacement roof conforming more closely to the original profile was fitted to the upper cab section. Following the trial fitting shown here, the cab section was grit-blasted to remove decades of paint and rust, repaired, body-filled and primed. • MOURILYAN's 2-stage Westinghouse air compressor as restored. With scored cylinder walls, frozen valves and a heavily rusted interior, it represented a major restoration challenge. For example, it took three days of gentle heating and cooling, and soaking in diesel oil, just to get one of the valves out. • The fully restored Gardner radiator. There are 116 individual copper tube risers, each with a copper crush washer soft-soldered on at the bottom to form a seat. The tubes seat into tightly-fitting rubber grommets top and bottom, and it took days to carefully coax each one into place, taking exquisite care not to force the rubber grommets into the cast iron tank housing. • Rewiring the instrument panel inside the loco's cab during the final stages of restoration. The pristine control console is a far cry from the wrecked interior shown in the photo above. All photos: Ian McNeil

The tropical north Queensland climate had been particularly severe on the exposed bodywork. Oyster rust had gouged pits of all shapes and sizes in the sheet metal, and expansive rust was busy inside many of the joints, forcing panels and angle brackets apart.

The front hood had to be taken completely apart and each panel, strut and bracket ruthlessly de-rusted. Wasted metal was built up through weld-deposition, though some of the smaller brackets were too far gone to be repaired and replacements had to be fabricated.

Abrasive blasting was used on the cab sections, as well as the loco's chassis, as the best and most effective way of removing rust and layer upon layer of old paint. It certainly is a very effective technique, but it was a bit depressing to afterwards view all the exposed metal that now required repairing, body-filling and sanding back. Hours of patient bogging and sanding ensued.

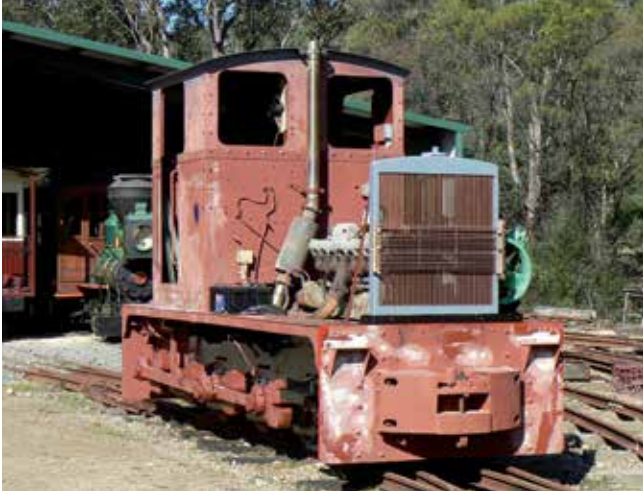
Dismantling and repair began to give way to restoration and reassembly during 2011. Here the chassis and cab components have been repaired, abrasive grit-blasted, primed and reunited. The overhauled radiator and air compressor have been plumbed up, and a pair of heavy-duty batteries installed. Photo: Ian McNeil

To bring the cab roof back close to its heritage outline, the taller QR-added roof was sliced off, and new steel plate formed to shape and welded onto the repaired upper cab section. A new rear hood was fabricated from scratch by a Sydney workshop that specialises in metal forming.

Inside the cab the life-expired wooden floor was scrapped and replaced by a more serviceable steel checker plate one. The control panel was a wreck and required extensive bogging and sanding to bring it back to life. Some of the control levers, gauges, indicator lights and switches were able to be refurbished, while replacements had to be found for others beyond repair. The 'modern' sliding windows – with and without glass – were replaced with fixed windows made to the original style.

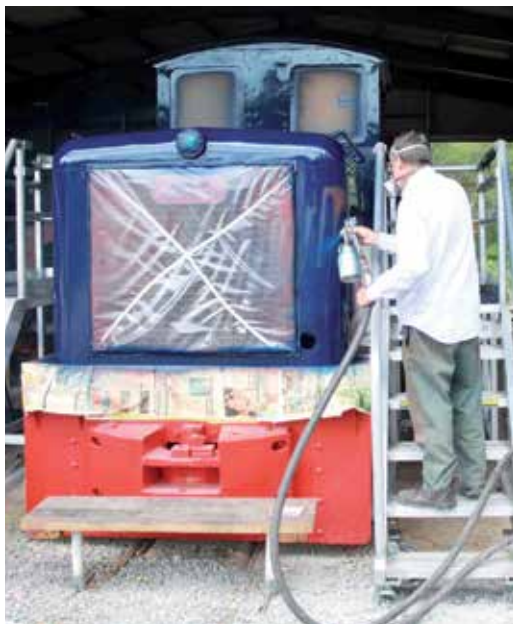
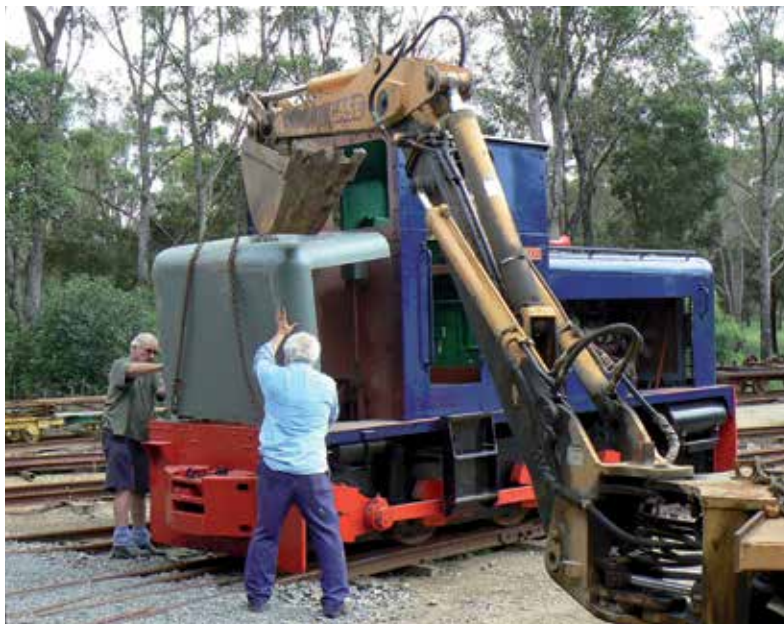
**Left:** Spray painting the royal blue top coat was undertaken on site. The original colour was able to be recovered from paint preserved under layers of subsequent coats inside the cab. Photo: Ed Boards **Right:** One of the last components to be reinstalled was an original-profile rear hood fabricated by a Sydney firm specialising in sheet metal bending. This replaced the cut-down hood installed during the latter days of QR ownership in Queensland. Photo: Ian McNeil

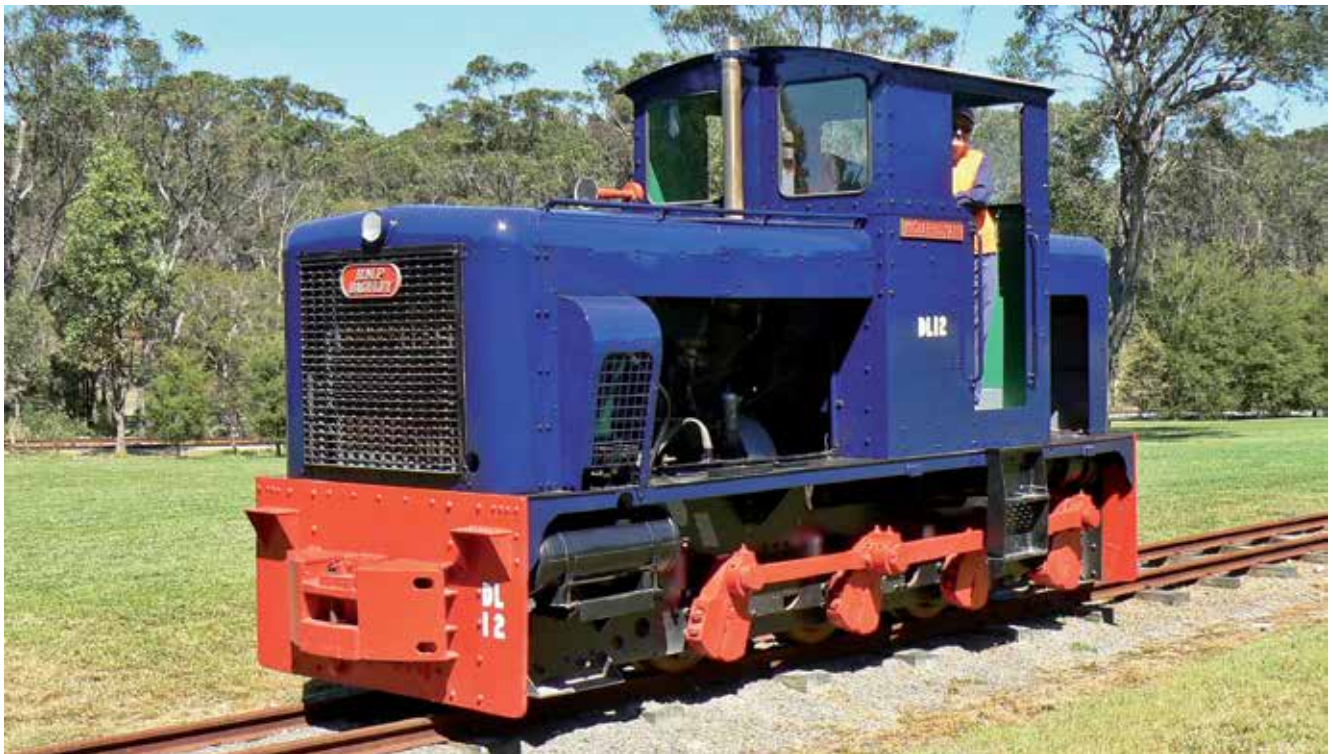
*The restored DL12 MOURILYAN (Baguley 3390 of 1954) on acceptance trials in October 2012. Restoration of the historic diesel-mechanical locomotive took over 2½ years and involved hundreds of man-hours of effort.*

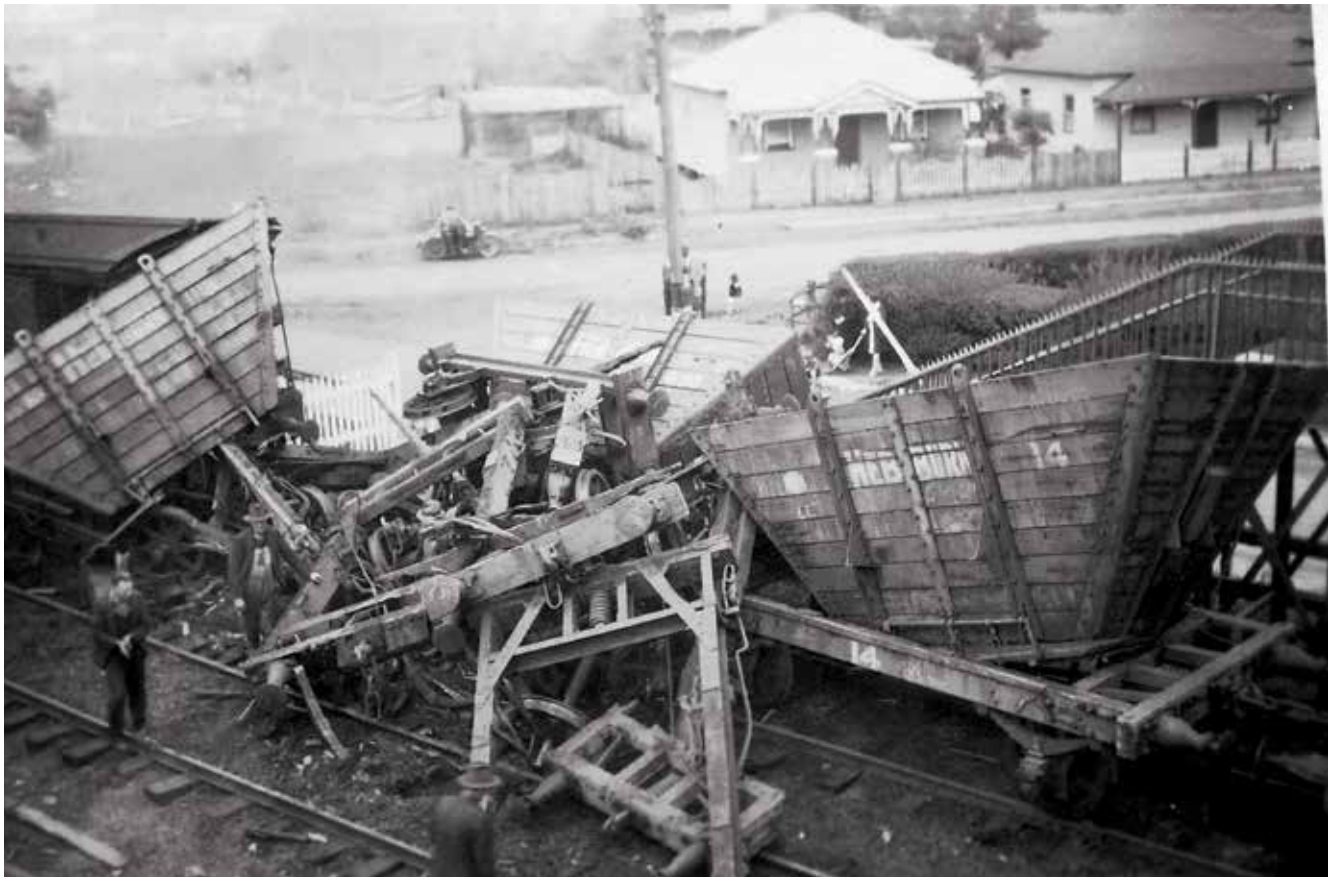
*'Self Destruction'. Wooden coal hoppers certainly came to grief in a spectacular manner. This is the 1942 accident referred to in the text. The photo, taken from the High Street Station footbridge, Maitland, includes the wreckage of seven Hebburn coal hoppers and a van. Photo: John Parker Collection*

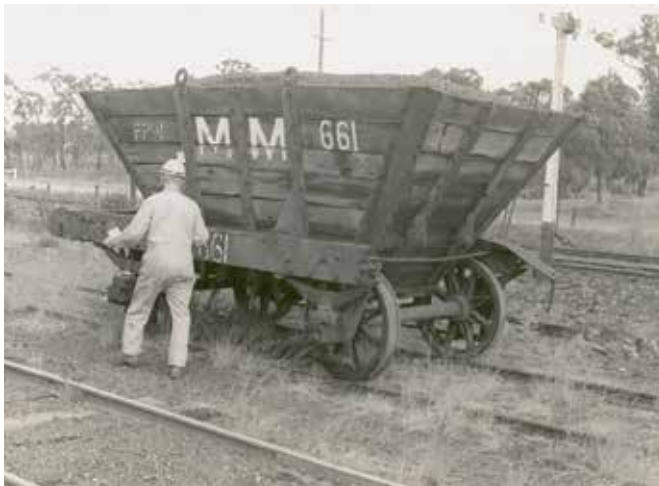
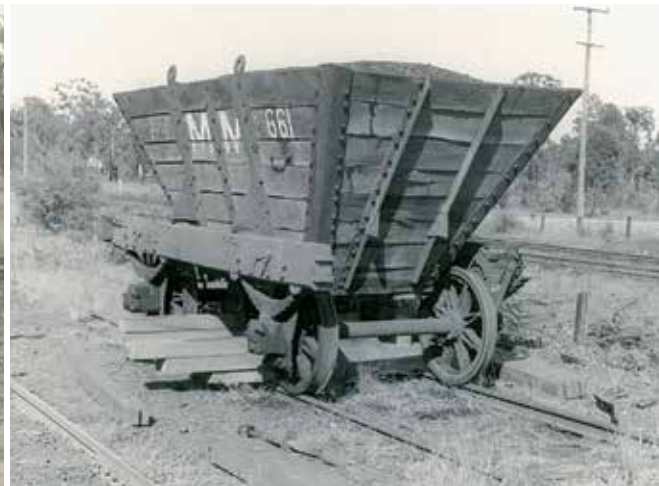
**Left:** “Lineside Makeover (1)” Maitland Main No 661 (on hire from PPW) has been set out at Neath with a pulled-out headstock. Colliery carpenter, Jim Moodie, sizes up the job, which will involve the replacement of both solebars, the headstock and cross brace. Photo: Author

### **Pulled out headstocks - broken solebars**

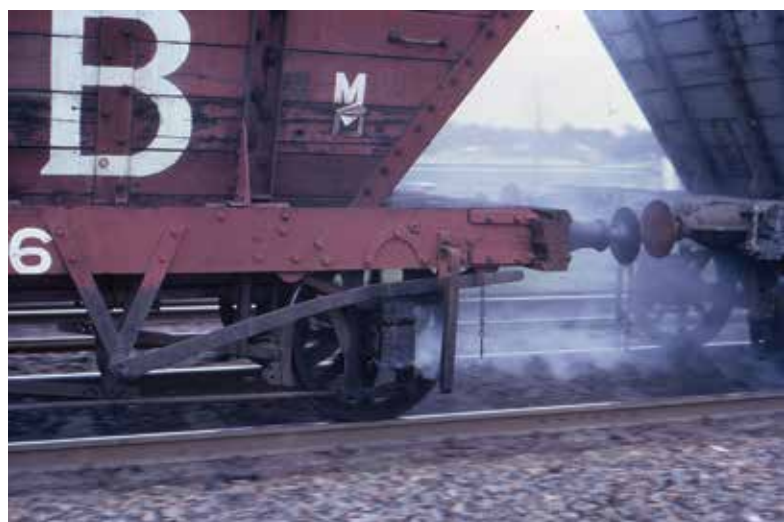
“Trailing blue smoke and smelling abominably of scorched cotton waste.”  
Near Waratah in December 1972, a J&A Brown hopper waggon appears to have developed a hot box. Photo: Graeme Belbin

Although overheated brass bearings were commonplace, due to the slow speed of coal trains they rarely developed to a dangerous stage. On some occasions the offending vehicle would be set out at the closest siding, but often (especially when empty) they were marked for attention and permitted to continue to the destination. It was not unusual for a train to arrive in the colliery yard with at least one vehicle singing a sad song, trailing blue smoke and smelling abominably of scorched cotton waste.

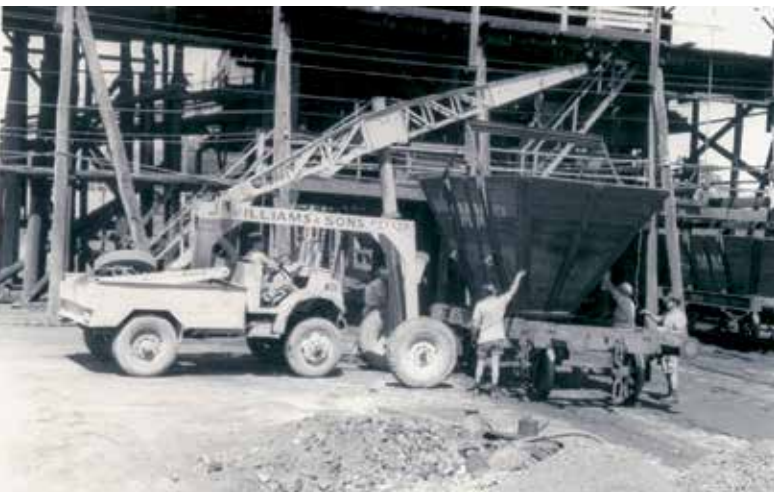
**Left:** "Saturday Shift". With the advent of the Dyke ship loader, the Railways Department required that all waggon brake levers be on the same side. Here at Maitland Main Colliery, one Saturday in 1969, the two waggon repairers, the carpenter and the shunter, spend an overtime shift turning waggons. One more job to keep the Department at bay.  
Photo: Author

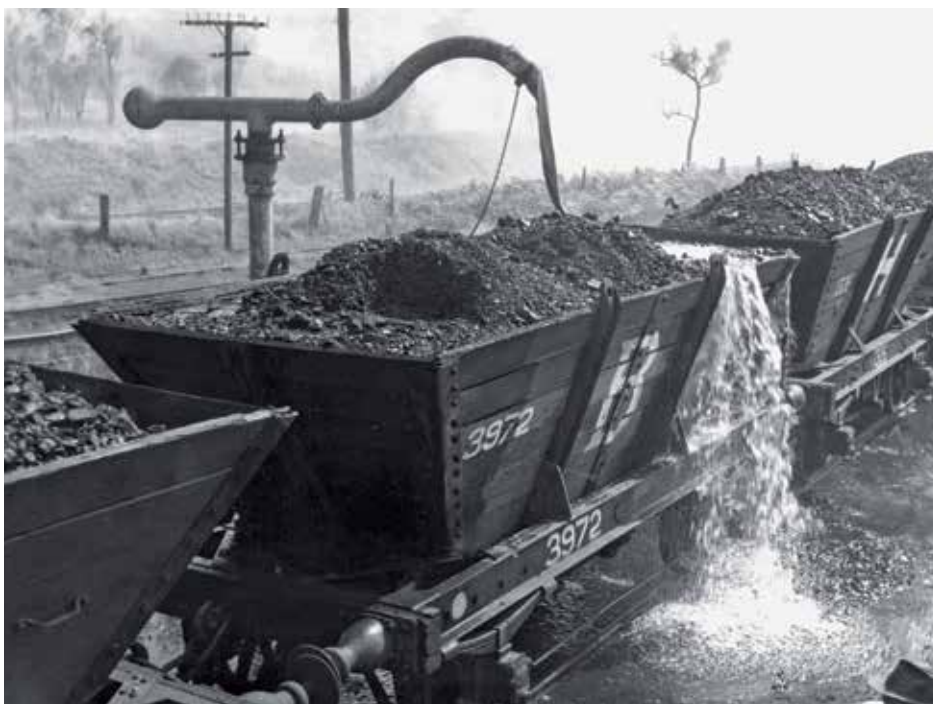
"Under a water column". On 21 January 1975, the water column at Weston is put to good use extinguishing a fire in J&A Brown hopper 3972. Photo: ARHSnsw Railway Resource Centre 9846

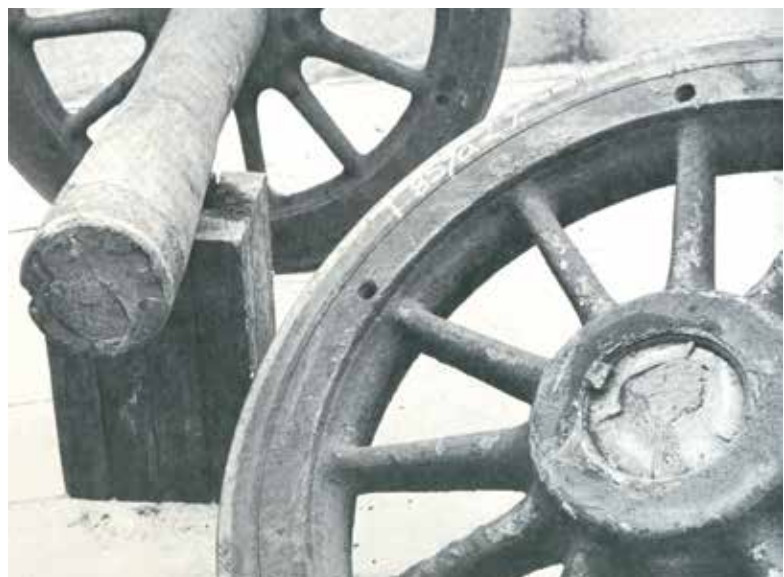
*"Snapped in Twain". As stated, axle fractures were rare, but they did occur.*  
*Photo: Author's Collection*

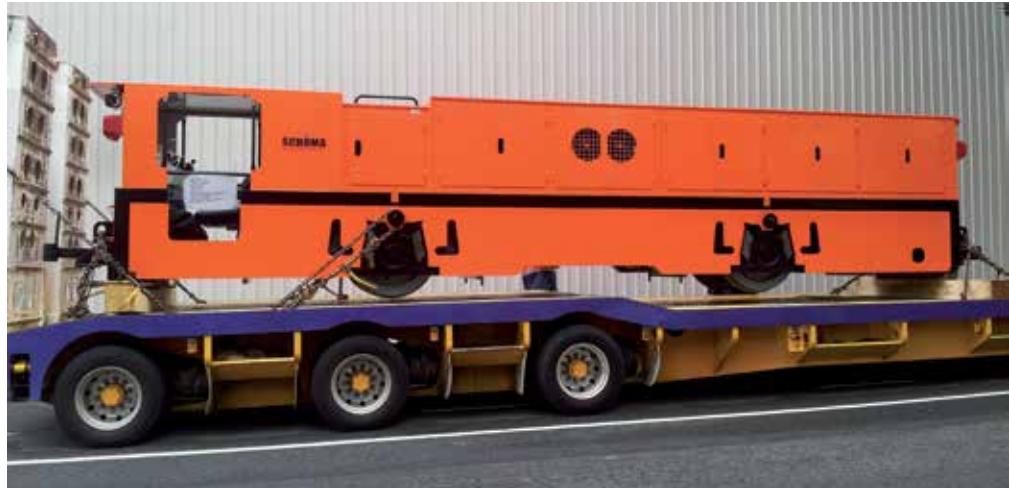
750mm gauge Schöma Model CFL 180 DCL 4wDH locomotive on delivery to the Thiess City East Cable Tunnel site in inner city Surry Hills, Sydney on 28 November 2012. Photo: Robert McFarlane

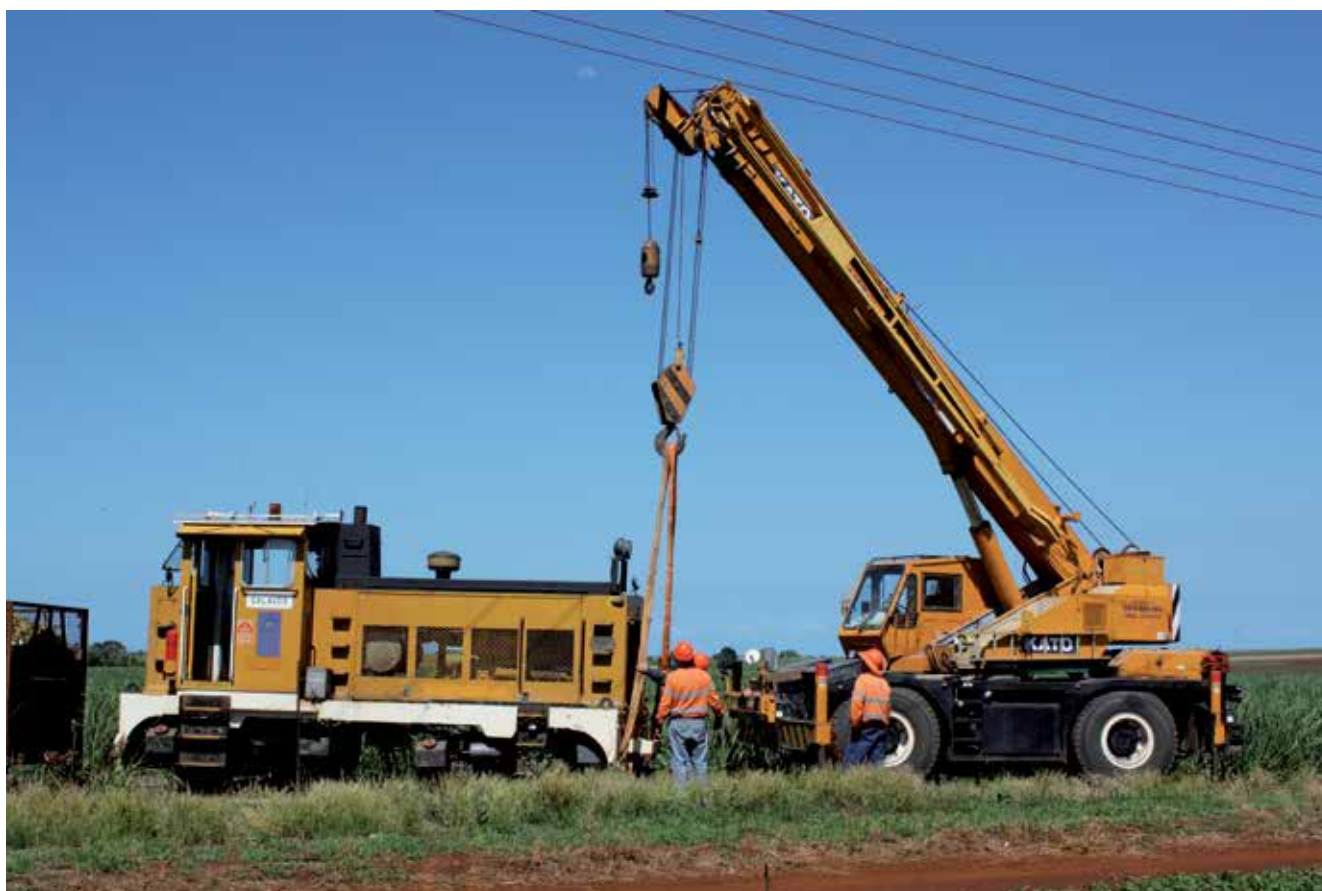
Amid the red soil of the old Qunaba Mill area, Millaquin Mill's EM Baldwin B-B DH CALAVOS (4983.1 1.73 of 1973) came a cropper on 22 November 2012 at Farquhars Road, on what is now known as the Qunaba Line, when a fishplate failed. Help arrived in the shape of a mobile crane and here the early model bogie Baldwin is being rerailed, with ten loaded bins to follow.

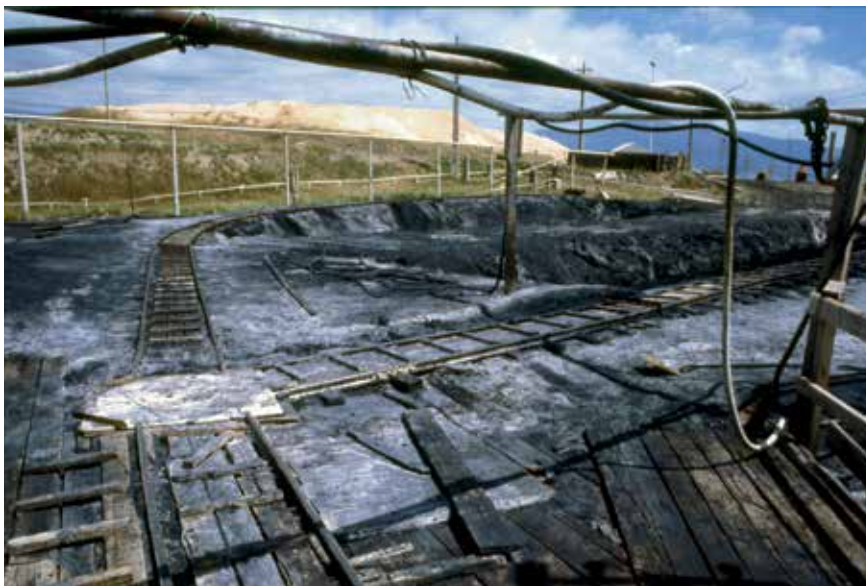
*Track to the dump, and turntable, at the electrolysis section, Risdon works, December 1987.*

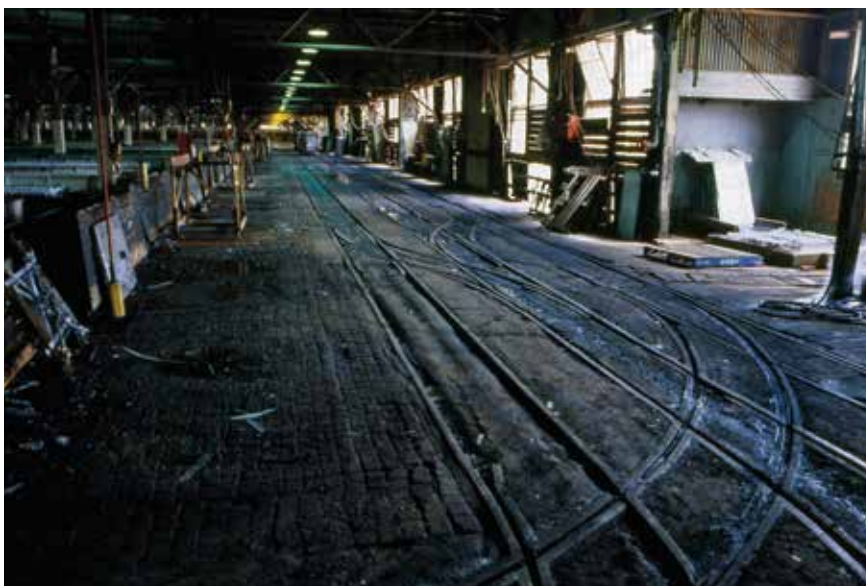
*The interesting track layout inside the building at the electrolysis section, Risdon works, December 1987.*
